Post-disaster construction and bearing replacement of Bahaddarhat flyover

M. Azadur Rahman & Sohrabuddin Ahmad
Acumen Consulting House Ltd, Dhaka, Bangladesh

ABSTRACT: A 1.37 km long four-lane flyover has been commissioned in October 2013 at Bahaddarhat in Chittagong city. Structural system of the flyover consists of precast post-tensioned concrete I-girders acting compositely with cast-in-situ reinforced concrete deck slab. On two occasions during construction one or more girders accidentally fell to the ground below. The latter accident caused fourteen fatalities. Post-accident investigation revealed serious flaws not only in construction, but also in design, supervision and project administration. Following an assessment of condition of the completed works, a systematic approach was adopted to repair and renovate the faulty works and complete the remaining works. The faulty elastomeric bearings were replaced after commissioning of the flyover. Recommendation for simple modification to end diaphragm design to aid bearing replacement is put forward. It is demonstrated that careful attention to details and a scientific and systematic approach can ensure safe construction and an a

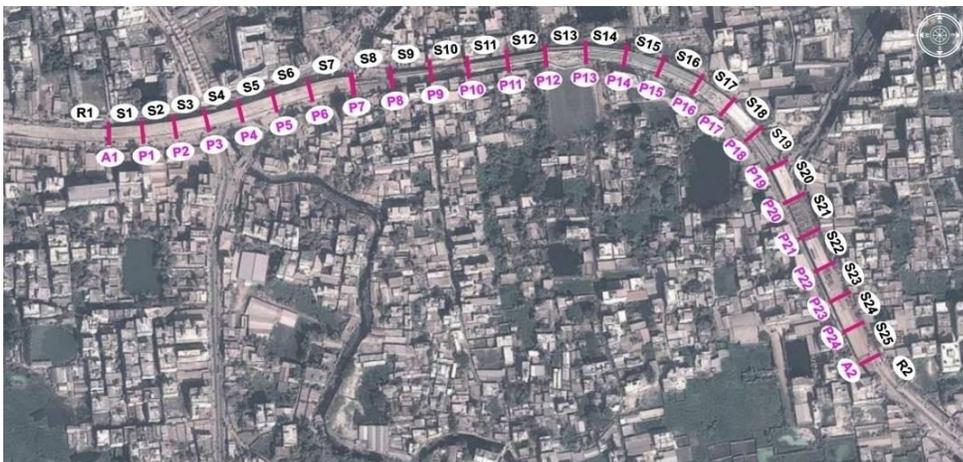
Figure 1. Satellite view of Bahaddarhat flyover after the accident

An aerial view of the flyover taken immediately after the accident is shown in Figure 1, where the supports and spans are identified for reference. The extent of construction of the superstructure up to the accident is discernible in the figure. The broken girders in span S13 which fell in the pond (pumped out to search for bodies) can also be seen.

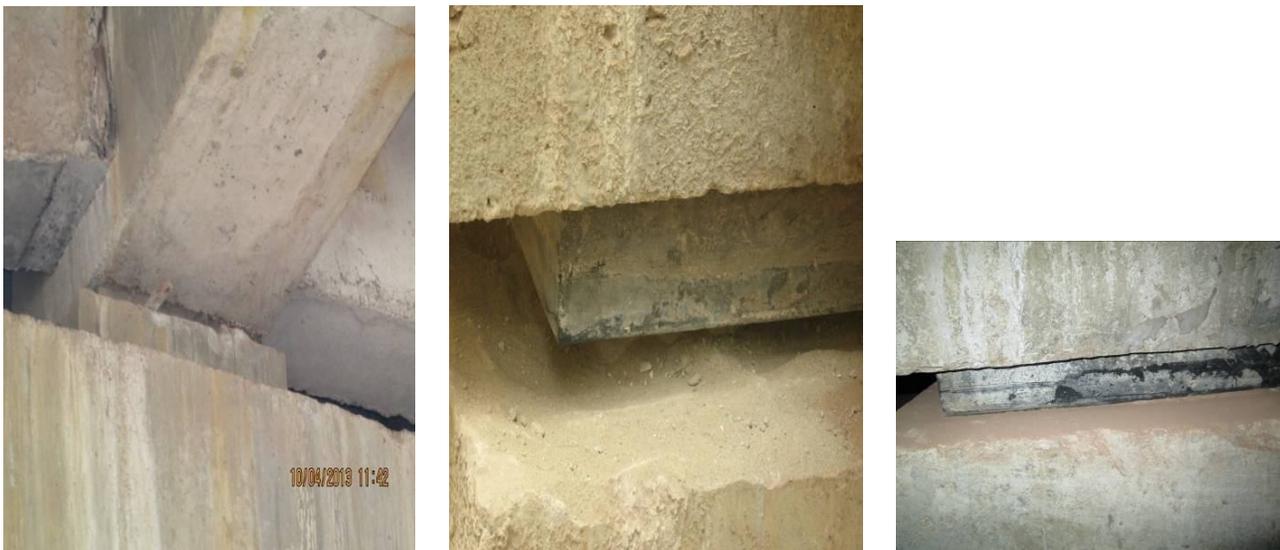
Figure 2. Samples of poor installation and quality of bearing pads

A total of 242 elastomeric bearing pads out of the required 336 had already been installed. Many of these pads exhibited various distress signs, such as lateral or reverse longitudinal sway due to eccentric application of load, bulging, crack, etc. Signs of faulty and careless installation were aplenty. Figure 2 shows two such cases of improper installation and a failed bearing pad.

a) Bamboo packing under bearing pad

b) Bearing pad floating on sand packing

c) Failed bearing pad

Besides faulty installation, material quality of the bearing pads fell short of required standards. According to technical committee report of the ministry (MHPW, unpubl.), tests conducted at BUET on bearing specimens collected from the accident site revealed that all the specimens failed to meet requirements of tensile strength, compression set, peel strength and heat persistence. Peel strength of the specimens was reported as zero against a specified minimum of 7 kN/m. The result was subsequently corroborated by physical tests on other 'approved' specimens lying in site store.

A total of 242 elastomeric bearings were installed prior to the accident, girders placed over them and deck slab cast. Many of these bearings exhibited signs of distress due to inadequate material quality and faulty installation. Bearings that had been approved for use were recovered from site store. Their quality was found to be so poor that layers of rubber could easily be peeled off from the rusted steel laminas by hand. These were discarded and new bearing pads used for the remaining girders. Prompted by evidence of poor quality of the bearings in site store, it was decided to replace all earlier installed bearings, although some of them did not so far show much distress. However, because of the urgency of opening the flyover to traffic, the operation had to be scheduled after commissioning when traffic would be travelling on the deck. In the planned operation one end of a deck with six or seven girders would be raised by synchronized jacking of all the girders. Upward movement of the deck would be some 20mm or just sufficient to allow the existing bearings to be taken out and new bearings installed. This ensured that the operation could be carried out while traffic is on the deck.

Space available on pier head in front of bearing plinths was inadequate for accommodating the required capacity jacks; the concrete there was also mostly outside the reinforcement cage and hence susceptible to spalling under load from jack. To tackle the problem, a bracket was fabricated from heavy steel sections to provide full or partial seating for jacks under the girders beyond the pier head top. The bracket system consisted of pairs of heavy channel sections placed vertically against the pier head on either side. Channels on the two sides of pier head were pulled against each other by HT alloy steel threaded bars thereby putting gripping pressure on the pier head concrete. Jacks were positioned on a cross head fitted to top of the channels, the jacking reaction being realized by mobilizing friction between vertical channels and pier head concrete. An alternative simpler bracket arrangement was used where part of the jack could sit on pier head concrete. The bracket consisted of a horizontal arrangement of channels placed at top of pier head that formed a local extension of pier head in front of bearing plinth. As part of the jack reaction will be transferred to pier head concrete, a pre-compression was applied by screw jack to top of pier head. This would reduce chance of spalling of pier head concrete under the jack. In both the arrangements it was necessary to jack up both spans on the two sides of a pier head so that no unbalanced forces occur that may tilt the brackets. This was done even when bearing replacement was required under one span only. A similar arrangement was also devised for replacing the bearings on top of the abutments.

Bearing replacement operation started some two months after opening of the flyover to traffic. All 242 bearings were replaced successfully with the traffic plying on the deck above.

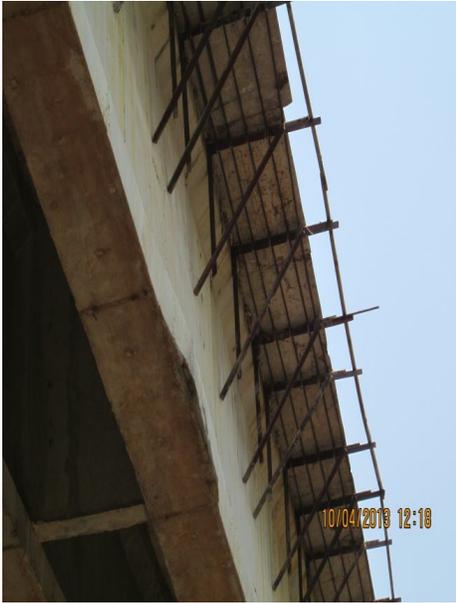
Methodology of construction of prestressed concrete girders had been concreting on overhead casting beds between pier heads, tensioning of cables on casting site, grouting of cable ducts and then lifting and shifting to their bearings. General appearance of the girders indicated poor formwork and workmanship, finished concrete faces not being neat and of uniform texture. Some of the girders were found to be bent horizontally indicating unbalanced tension applied to tendons due to faulty stressing sequence and cable profile. An example of poor workmanship of girder is shown in Figure 3.

Figure 3. Bulging of girder concrete due to poor formwork

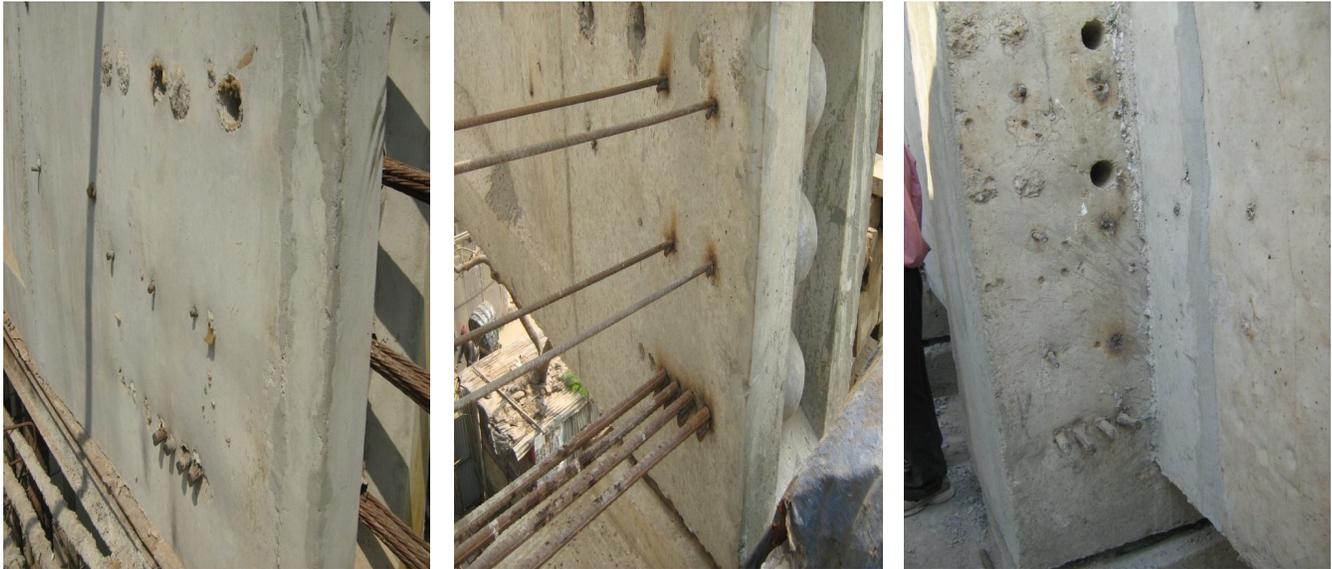
Figure 4. Faulty construction of diaphragms

Diaphragms contribute to the integrity of PC girder and deck slab system and distribute concentrated vehicle loads among the girders. It appeared from the quality of construction of the diaphragms that no regard for their importance crossed the minds of the builders. During lifting and shifting of PC girders, most of the continuity bars embedded in the girder for lapping with diaphragm bars have been cut off for convenience of attaching lifting/shifting collars. For some diaphragms, bars had already been fabricated but casting not done yet. In these reinforcement fabrications it was found that adequate lapping of bars had not been provided, some with only 25 to 50 mm nominally welded lapping. In some cases position of the diaphragms were found to be misaligned with the embedded bars kept in the PC girder, missing them completely. Some such embedded bars are visible outside the diaphragm. Already 32% of the diaphragms had been cast, most likely ignoring the above issues. Photographs of some typical diaphragms are presented in Figure 4.

a) Continuity bars shaved off b) Inadequate lap of diaphragm bars c) Misaligned diaphragm

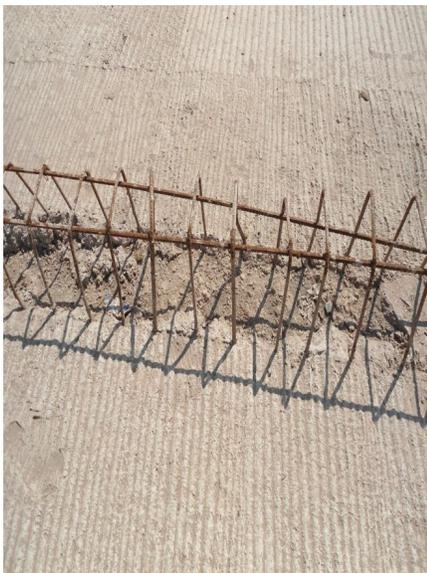
Out of the total 25 deck slabs 12 had already been cast with inappropriate line and level, rendering it difficult to correct the profile for the remaining decks. The difference of levels of the constructed deck from the design level was as high as 87 mm with some of them being constructed in a cross slope that is opposite of the design. As per design a 50 mm thick concrete wearing course had been laid over the RC deck. The surface finish of the wearing course was extremely poor and unsuitable as a riding surface. The wavy pattern of a finished deck is shown in Figure 5. There is no alternative but to lay an asphalt wearing course on top of the existing surface to provide a suitable riding surface. The four-lane deck of this urban flyover has been provided with a width of 6.5m for two lanes in each direction. This being inadequate as it is, the efficiency has been further reduced by not providing required deck widening on curves. Besides, the designed median barrier is a mere 300

Figure 5. Poor riding surface of deck

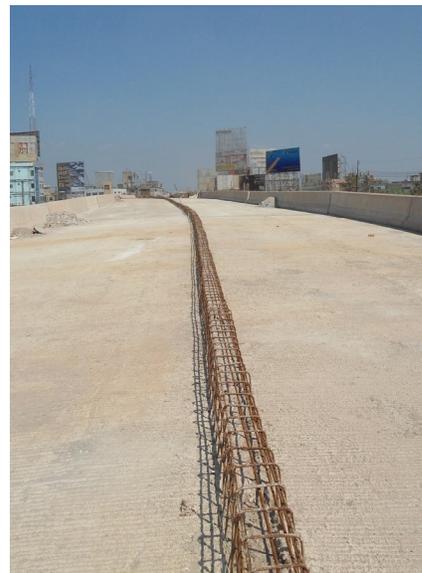
mm high concrete strip. Such low median is unsuitable for an urban flyover; headlight glare of opposite vehicles will cause driving hazard; it may be crossed by errant vehicles causing serious head on collisions. It may also be crossed by jay walking pedestrians. Reinforcement kept in deck slab for the median barrier can be seen in Figure 6.

Figure 6. Rebars for low height median

Median strip was originally designed as a 300mm high concrete barrier with a base width of 300mm and a top width of 250mm. The median design was revised to render it safer, but the base width had to remain fixed as otherwise the already restricted roadway width will be further reduced. Keeping the same side slope as in original design and making the top width 150 mm, a height of 950mm was achieved from which 30mm would be lost to asphalt wearing course. Although a non-standard shape, the new median design was made structurally adequate for the anticipated vehicle impact load.

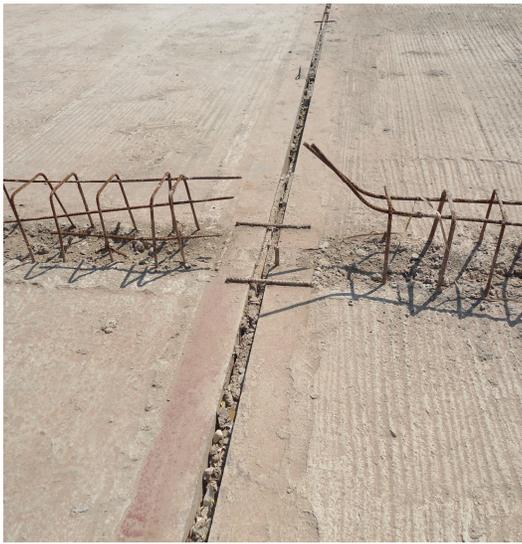
Inter-span expansion joints have been designed as 25mm gaps with a 20mm wide rubber strip insert. Steel edge beams that appeared to be makeshift contraptions made from rolled angle sections without adequate anchorage to deck concrete were found to have been installed. No rubber strip was yet installed. Clearly the expansion joint design is quite inadequate and unbefitting of a modern flyover. The poorly anchored edge beams are likely to soon be dislodged under vehicular impact creating a bumpy ride condition. The loosely inserted rubber strip will be extruded by wheel impact and deck expansion; they will also provide no seal causing rain water to percolate in the bearing area underneath, causing the bearings to deteriorate fast. Figure 7 shows an installed expansion joint and an inadequately anchored makeshift edge beam ready for deck concreting.

a) Installed expansion joint

Expansion joint design is faulty on two accounts: the joint gap is not sealed thereby allowing deck water to seep into the bearing area underneath, and the joint edge beams are not adequately anchored to deck concrete. As riding surface of the constructed concrete wearing course was unacceptable, it was decided to lay a 30 mm asphalt wearing course on top. This would raise level of deck surface necessitating raising the expansion joints as well. It was decided therefore to discard all installed expansion joints and replace them with properly manufactured strip seal joints.

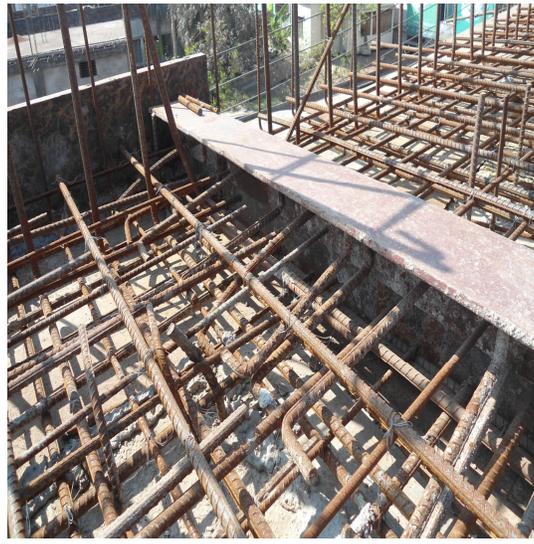
b) Makeshift edge beam with inadequate anchorage
