Rehabilitation of Meghna and Meghna-Gumti bridge superstructures

ABSTRACT: The two bridges on Meghna and Meghna-Gumti rivers on Dhaka-Chittagong highway have been serving road traffic for the last 15-20 years. They had deteriorated significantly and their safety and serviceability threatened due to a virtually non-existent maintenance program. Mid-span hinge bearings of both the balanced cantilever box girder bridges had worn out and the reinforced rubber expansion joints had all but disappeared. The deck deflected and vibrated significantly as heavy vehicles passed, the piers swayed, riding over the expansion joints became bumpy and dangerous. A major rehabilitation work was recently undertaken which involved installation of new expansion joints and replacement of hinge bearings to stabilize the bridges. This paper describes the rehabilitation works, including inter alia design of new expansion joints, and material and method adopted for replacement of hinge bearings. It also addresses implementation issues and experience including bridge closures for minimum interruption.

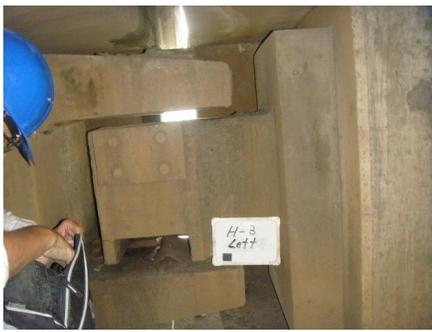
RHD intended to address the issue of protecting the bridges from immediate damage by taking some temporary measures aimed to reduce vibration of the bridge by inserting rubber and steel plates in gap of hinge joints of Meghna Bridge. Before actually inserting these packing plates, measurements of total gaps (sum of upper and lower sides of hinge) on both sides of each hinge were taken. These data are presented in Table 1.

a) Gap before packing

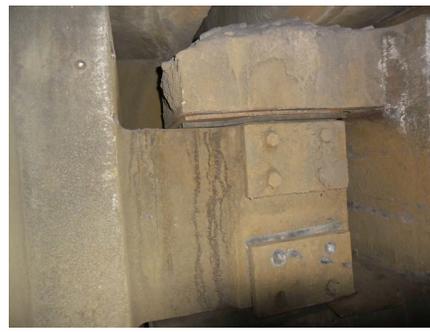
b) Steel and rubber packing

As the gaps were of variable thickness, steel plate and rubber sheets of two thicknesses (10mm and 5 mm) were used in required number to fill the gaps and then tied together with bolts. The job was done with traffic plying above, the packing inserted at the opportune moment of a maximum gap created due to movement of a heavy vehicle. The work was difficult and only five of the nine joints of Meghna bridge could be partially filled with packing plates and no work was done on Meghna-Gumti bridge. Even in these, rubber plates could not be inserted in six locations due to not getting sufficient clearance in the gap. Photograph of a typical gap before and after insertion of the packing is shown in Figure 1. While this measure reduced relative vertical movement between male and female parts of the hinge, it did not facilitate free sliding and rotational movements required for proper function of the hinge.

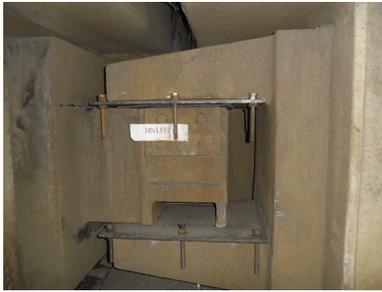
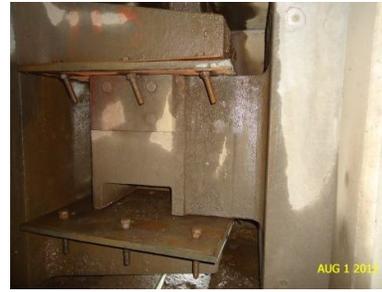
During the course of this work it was discovered that the packing plates easily came off due to vibration caused by passing traffic. Various arrangements were tried to prevent slipping out of the packing from the hinge gaps but none was satisfactory. One such attempt is shown in Figure 2.

Figure 2. Failed attempt to stop slipping out of packing due to deck vibration.

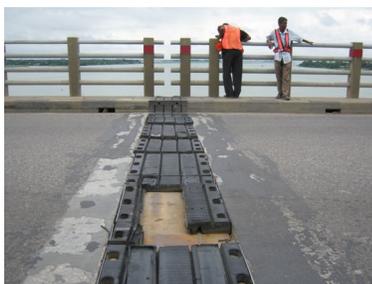
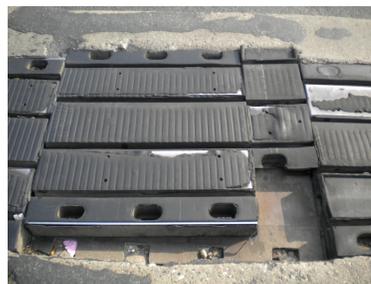
Condition of the bridges remained critical as the interim measures were not successful. Most of the hinges of both bridges continued deteriorating with abnormal vertical movement and vibration as traffic passed. As vehicles passed over the joints, male and female parts of the hinge hit each other creating loud hammering noise that caused safety concern among drivers and passengers. As a result most vehicles would stop before the joint and cross it very slowly creating long tailbacks on the bridge. Such stopping and slowing down of vehicles were also prompted by the deteriorated expansion joints which no longer could be viewed as serviceable. Deterioration of hinge bearings at the mid-span expansion joint locations had resulted in significant vertical movements being imposed on the joints. The type of expansion joint used did not cater for any significant vertical movement between two sides of the joint. Condition of a typical expansion joint prior to rehabilitation is shown in Figure 3. Wheels of loaded vehicles would frequently get stuck in the damaged joints creating traffic disruption.

Figure 3. Expansion joint before rehabilitation.

gaps and increased traffic. Design of bearings should pay special consideration to sliding movement and the resulting abrasion of bearing surfaces. The expansion joints employed in the original design were extremely maintenance hungry and short lived as rubber would soon deteriorate under prevailing extreme traffic conditions. All of the expansion joints needed replacement by a more durable form of joint with little maintenance needs.

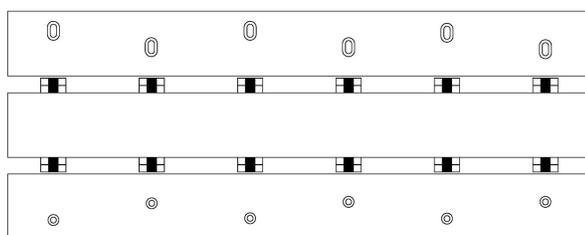
Figure 4. Temporary expansion joint.

Temporary expansion joint was designed to immediately and temporarily bridge over the gaps by cover plates. This would allow traffic to pass relatively more smoothly without having to slow down. The design consisted of three plates hinged together, with the outer plates being anchored to deck concrete. Service movements, mainly rotations and longitudinal movements were accommodated respectively by hinges on both ends of the bridging plates and slotted holes on anchor plates on one side (Fig. 4).

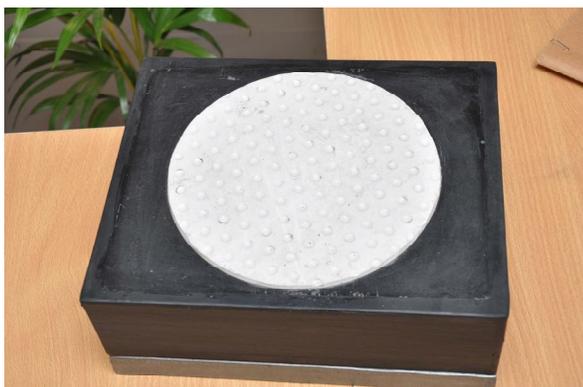
Figure 5. Temporary PTFE topped elastomeric bearing.

All the old pot bearings were removed; the gaps thus created would eventually be filled by new sliding pot bearings. Until the new bearings are designed, manufactured and performance tested, some temporary packing that would transmit vertical force yet allow rotation and sliding needed to be devised. Elastomeric bearing complete with dimpled polytetrafluoroethylene (PTFE) disc was adopted as this design could be produced in short time. The upper PTFE disc was smeared with silicon to facilitate sliding due to horizontal deck movements. The bearing lower assembly was designed with tapered face; tapered packer plates were used so that the bearing assembly could be fitted tightly into its location between male and female couplings of the joint. Figure 5 shows such a temporary bearing.

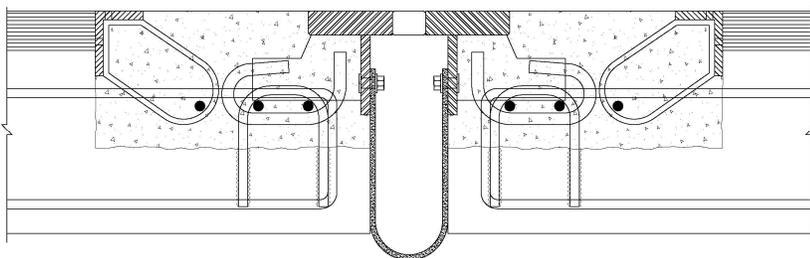
Figure 6. Expansion joint section.

In design of the permanent expansion joints, riding comfort and low maintenance need were given the topmost priority. A finger type joint was preferred mainly because it satisfies both these conditions. Additionally it would accommodate large vertical movements. Figure 6 shows a typical section of the designed finger joint. Although it is an open joint, deck water could be collected in a channel made of polyester fibre reinforced rubber and drained into the river. Thus the bearing area underneath would remain protected. The permanent finger type expansion joints with 50mm and 80mm longitudinal movement capacities were designed with Grade 50 steel to provide good riding comfort under service movements and to accommodate design wheel loads in excess of 130 kN due to overloaded trucks. Protection angles were incorporated into the finger joint design to protect the transition concrete against cracking due to impact loads. Looped anchors were used to firmly anchor the joint assembly to concrete deck. All exposed surfaces of the finger joints and the protection angles were protected against corrosion by chlorinated rubber anti-corrosion protection system having total DFT=450 μm .

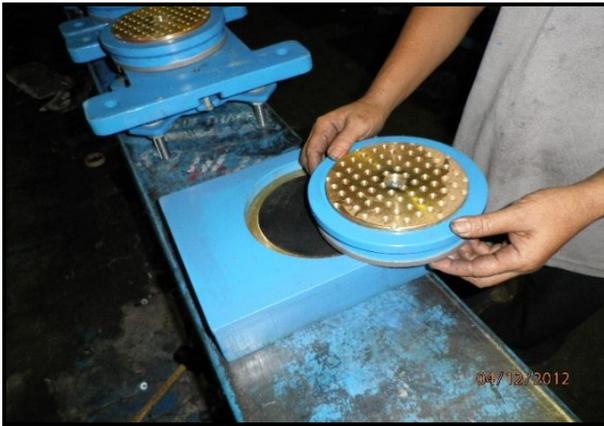
Figure 9. Assembly of permanent hinge bearings.

The permanent bearing was a modified version of the original design to BS 5400 with dimpled brass sliding disc (Fig. 9). The new design has a thicker sliding plate, the stainless steel material having been changed from S304 to the more durable S316. Although long term deterioration tests were conducted on the assembled hinge bearing (Fig. 10), when tried in field, this modified version of original design was not very successful because the dimpled brass disc could not withstand the prevailing frequency of combined movements. Despite having greased the brass discs frequently, they were worn out within a short period after installation. It was felt that a non-metallic material would form a more abrasion-resistant sliding surface. After considerable test and trial, ultra high molecular weight polyethylene (UHMWPE) was chosen as material to be used on piston tops of pot bearings to act as the sliding surface. Originally installed dimpled brass discs were replaced with custom-designed and machined dimpled discs using UHMWPE material. This special design UHMWPE disc has proven to be successful ever since under extreme service movements and rotations (Fig. 11).

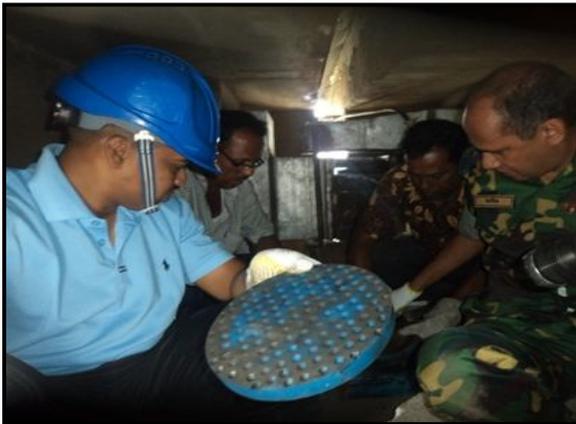
Figure 11. UHMWPE disc in excellent condition after months of service.

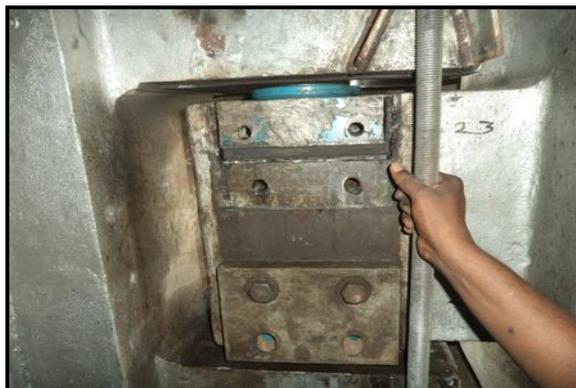
Figure 12. Stress bar clamping system in hinges.

The other additional item supplemented to the original hinge bearing design was the introduction of clamps at the hinge using M36 stress bars. The clamps were introduced as preventive measure to “walking” of hinge bearings under extreme frequency of rotational and torsional movements at the hinge. The stressed clamping bars held together tongues of the female coupling which deflected under dynamic action of heavy traffic (Fig. 12).

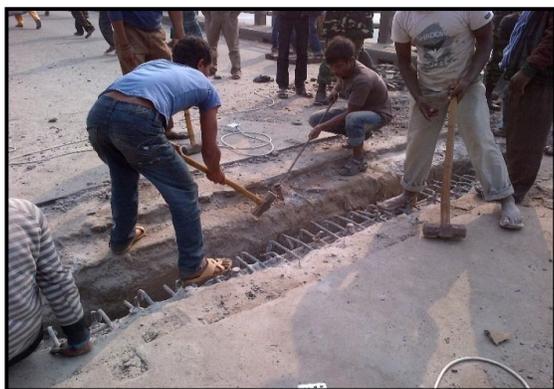
Figure 13. Hacking of concrete box-out.

The bridges were closed to traffic for 6 consecutive days on 3 occasions during the installation of permanent solutions. This was unavoidable because the permanent design required concrete box-out to be provided to cast in the finger joints. Hacking of the 20 years old concrete (Fig. 13) and aligning the anchors of finger joints within the obstructive starter bars (Fig. 14) were challenging and had taken up most of the isolation time allowed.

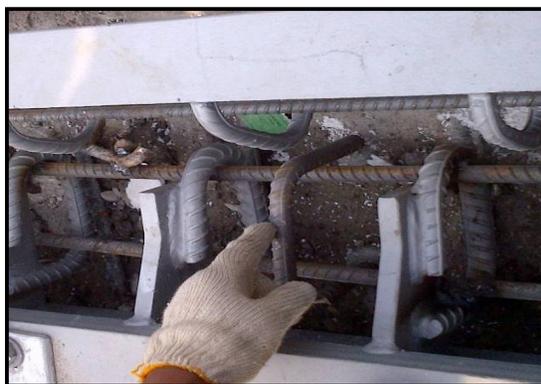
Figure 14. Finger joint installation in obstructive starter bars.

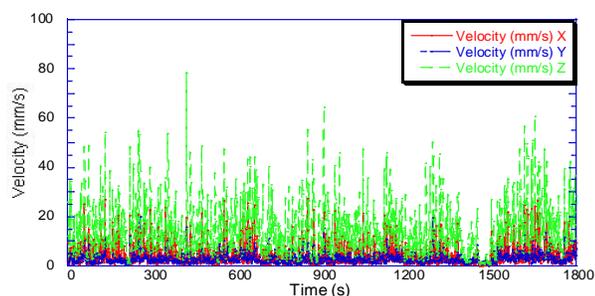
Vibration of the bridge was measured before and after the rehabilitation by electronic vibration sensors and loggers that can record vibration in all three dimensions. Figure 17 shows the equipment employed for this measurement and Figure 18 shows vibration monitoring work on bridge deck. Figure 19 and Figure 20 respectively show typical vibration records before and after the temporary rehabilitation works. Peak velocity of 80 mm/s prior to rehabilitation had reduced to below 60 mm/s after the temporary works. The measurements were however taken over a short period of time (30 minutes) and may not represent typical traffic condition on the bridge.

Figure 19. Bridge vibration before rehabilitation.

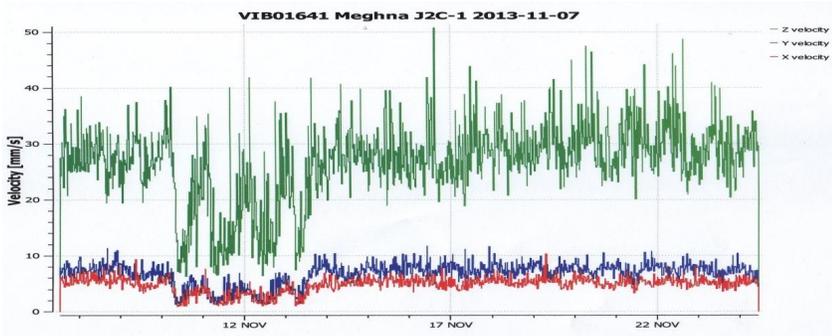
After commissioning of the bridges subsequent to permanent rehabilitation works, a continuous record of vibration spanning over 17 days was taken. The velocity against time measurement for this period is presented in Figure 21. There is clear evidence that deck vibration has reduced considerably due to the permanent rehabilitation works. Peak velocity was about 50 mm/s only once during the recording period of 17 days, this presumably due to passage of a very much overloaded vehicle. The maximum velocity in the vertical direction was generally below 40 mm/s. Velocities in the two horizontal directions were below 10 mm/s.

Figure 21. Vibration record after permanent rehabilitation works.
