External post-tensioning of pier heads and bearing replacement of Hatirjheel bridge #4

M. Azadur Rahman & Sohrabuddin Ahmad
Acumen Consulting House Ltd, Dhaka, Bangladesh

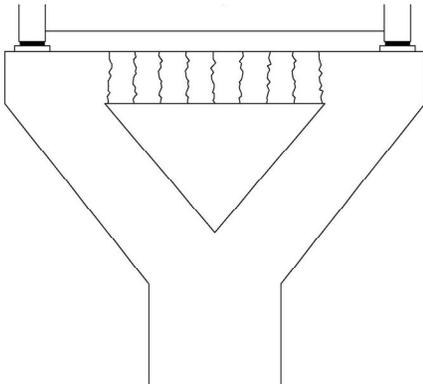
Figure 2. Cracks in pier head

Soon after commissioning of the bridge in early 2013, cracks appeared in top tie members of both pier heads (Fig. 2). Cracks on the faces were vertical turning around to form complete rings around the member. Regular monitoring of the cracks showed that both their number and width increased rapidly. It was realized that the members have failed in tension and were on the verge of severing altogether. In such an event, upper arms of the Y of pier head would act as free cantilevers, causing them to suffer excessive deformation and most possibly collapse. The cracks were many, at least 8 or 9 per member by the time remedial measure was undertaken. Widths of the cracks were also significant some exceeding 2 mm.

Structural drawings of the bridge show that tie members have a 1500×1200 mm rectangular cross section reinforced with 12- $\phi 25$ and 6- $\phi 20$ bars providing a total steel area A_s of 7776 mm^2 . Ignoring concrete contribution in resisting tension and also the negligible flexural stress due to self weight, the stress developed in steel reinforcement for dead load and full design live load comes to $(4104 \times 1000/7776) = 528 \text{ MPa}$. The corresponding stress due to dead load alone is 422 MPa. Design yield stress of the steel used being 413 MPa, the reinforcement has possibly yielded, or at best has had excessive deformation if full design live load has not yet been applied. The possibility of the tie member being severed causing a total collapse of the substructure together with the superstructure was a reality.

Since the tie member has already failed for all practical purposes and was on the verge of severing, it was necessary to reverse the failure by application of forces counteracting the structural action. Any attempt to repair and seal the cracks would be futile. As strength of the member was inadequate due to deficient design, retrofitting to make it adequate was warranted. Passive retrofitting by adding reinforcement such as bonded CFRP strips or wrapping would add to strength but not reverse the distress that had already taken place. Strengthening the member by external post-tensioning was the logical solution.

As the member is permanently subjected to pure tension with negligible associated flexure, post-tensioning need be applied only in the axial horizontal direction. This can be achieved by tensioning straight high strength bars on exterior vertical faces of the member pressing together ends of the member through anchor blocks. Using threaded bars would be more convenient to anchor than prestressing strands. It was decided to apply axial compressive force to the tie member to overcome most of the design tension 4104 kN substantially relieving the reinforcing steel which might have already yielded.

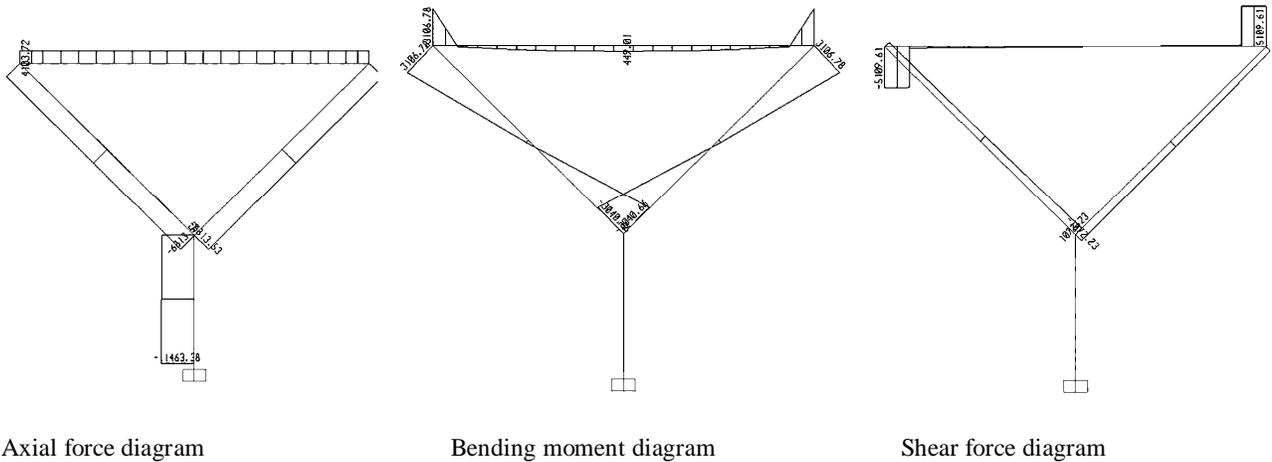
Figure 3. Pier analysis results (kN, m)

Dead load of each span of the bridge was 800 ton being carried at only four locations on supports, producing a dead load bearing reaction of 200 ton. Live load reaction at each bearing was calculated as 50 ton. Each pier head carries two spans on four elastomeric bearings, a pair at each end of tie member at top of the arms of Y. The concentrated force thus applied at each such location on pier head was $(200+50) \times 2 = 500$ ton. An analysis of the pier for this gravity load revealed that the tie member was subjected to a uniform tension in excess of 4104kN. Axial force, shear force and bending moment diagrams of the pier under combined dead and live loads are presented in Figure 3.

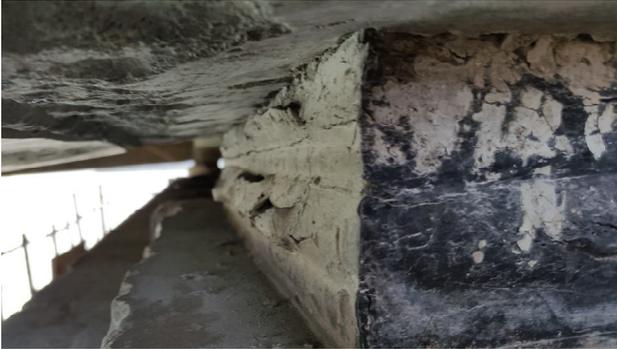
Figure 6. Condition of a typical bearing

When work of retrofitting was being performed, it was observed that elastomeric bearings under the girders, both on the piers and on the abutments, exhibited signs of failure in the form of splitting and bulging (Fig. 6). The bearing area was found to be wet and dirty due to seepage of deck water through expansion joints. As situation was the same for all the bearings, it was considered necessary to review design and quality of the bearings and correct the problem.

The elastomeric bearings were 550×400×91 thick with five layers of 3mm thick steel laminas. When checked by performing calculation in accordance with AASHTO LRFD Bridge Design Specifications (6th ed, 2012), the design was found inadequate to carry the required bearing reaction of 250 ton. A revised design with 550 × 530 × 91 thick bearing having five 3 mm steel laminas would satisfy all requirements of AASHTO Method B. The new bearings have been manufactured to strict quality checks and accepted after satisfactory performance in all relevant tests at independent laboratory.

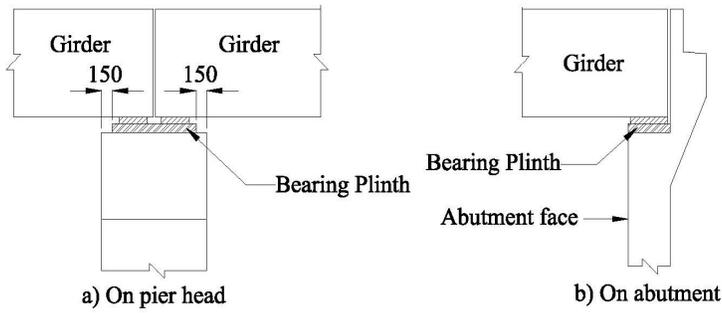
Figure 7. Inadequate space in front of bearing plinths

With traffic closed, lifting one end of the deck to replace the bearings would require at least 200 ton jacking force under the end of each main girder. Bearing plinths are so constructed that there is only 150 mm space available on pier heads for locating jacks under the girders, 50 mm of this being cover concrete beyond the reinforcement cage leaving only 100mm for seating the jacks. On the abutment side, there is no room at all for placing jacks under the girders as bearing plinths there are constructed flush with abutment face (Fig. 7). An alternative and more convenient location for placing the jacks would be under the end cross girders. But they were found to be inadequate for this loading condition; an analysis showed that only about 80 ton of jacking force can be applied on these members, the remaining 120 ton must be carried by jacks placed directly under the girders. The lifting scheme was to employ five 100 ton capacity jacks at each of the two corners of a span on pier head, three being placed directly under the main girder and two under the cross girder. Thus a total of ten jacks operated synchronously by a single pump and a system of manifolds were used to lift one end of a span. For the abutments however, placing jacks in front of the bearing plinth was not possible. A bracket bolted to the abutment was designed to act as a platform for jacks to be placed directly under the girders (Fig. 8). Figure 9 shows replaced bearings under girders of two adjacent spans on a pier head.

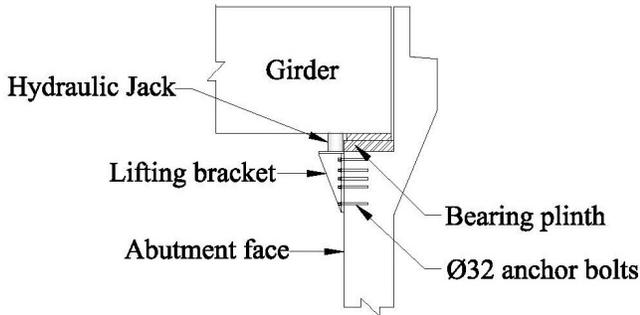
Figure 8. Lifting bracket for abutment front

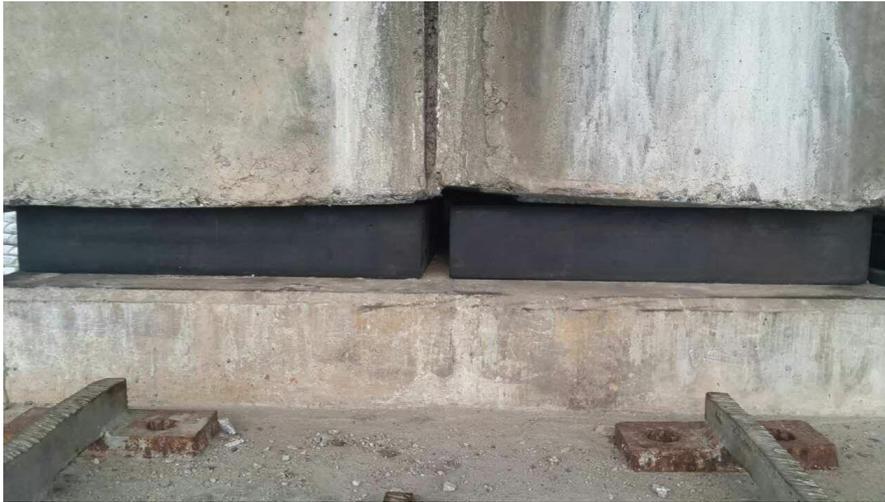
Figure 9. Photograph of replaced bearings
