# Structural condition assessment of bridges and culverts in national highway N7

**ABSTRACT:** Deterioration of structures with the passes of time especially for bridges and culverts is a common phenomenon all over the world. Deterioration may happen due to different reasons like poor construction quality, overloading, and structural inadequacy, lack of maintenance and monitoring, ground settlement and weathering effect. Due to lack of timely mitigation measures, deterioration often causes the severe structural damage and warrant untimely expensive repair or replacement of the structures. In Bangladesh, the growth of economy is consistent for the last few years and accordingly blooming in transportation sector happened. To meet the future traffic and transport demand some of the road structures mainly bridges and culverts are being structurally inadequate. Recently a survey has conducted to assess the structural conditions of bridges and culverts on National Highway N7. On the basis of which, an up-to-date inventory was prepared. The survey results signify that some of the bridges and culverts are inadequate to carry the increased traffic load. Some of them are at slightly deterio

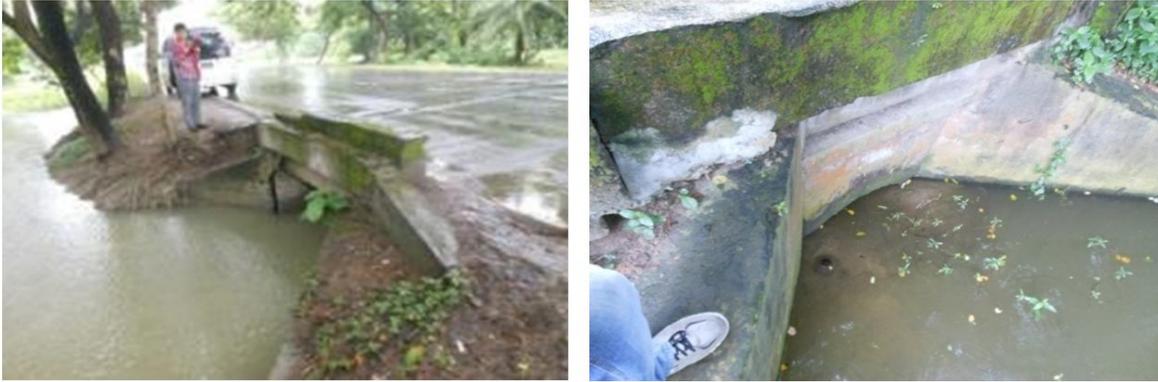
It was observed that a good number of structures deteriorated over the years after construction due to different factors. It was clearly observed that Box Culvert, PC Girder Bridge, Arch Masonry and Truss structures performed well than RCC Bridge and Slab Culvert. The actual deteriorated condition of these structures is presented in Figure-4. The deterioration may be occurred due to different conditions like repeated overloading, unexpected extra loading before the life expiry period, quality control during construction, inappropriate maintenance and lack of regular inspection as well as monitoring, weather conditions, improper drainage and gradient and reinforcement corrosion etc.

Figure 4. Deteriorated structural condition in (a) Slab Culvert at chainage 211+018 and in (b) Arch Masonry at chainage 5+028
