# Geotechnical problems of bridge construction in Bangladesh

A.M.M. Safiullah\*

*Department of Civil Engineering  
Bangladesh University of Engineering and Technology, Dhaka 1000, Bangladesh.*

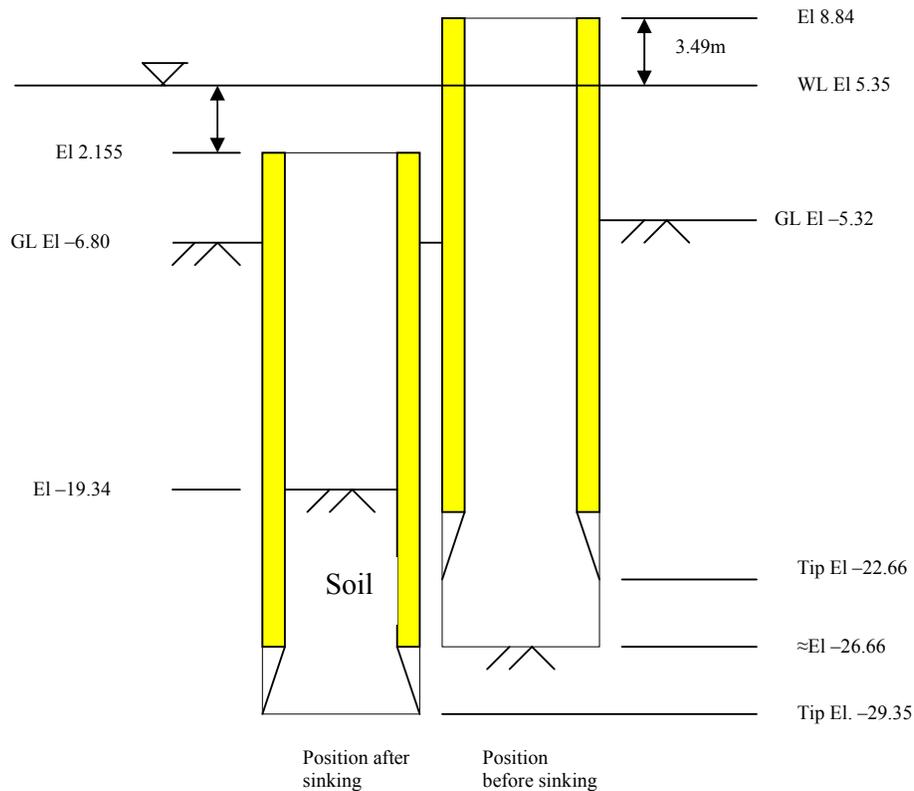
During middle of September 1996, difficulties developed during construction of the caisson foundation for pier no. 17. After the caisson was sunk to a depth of about 16 m. there was difficulty in further sinking although grubbing and soil removal from inside of the caisson was in progress. Some 4 to 4.5m of soil were removed from inside the

caisson but the caisson did not sink by its own weight. There were no inbuilt outer jetting arrangements within the caisson walls. At this stage the contractor used a 1.5-inch GI pipe 18 m long to inject water close to the caisson wall and this jetting continued at one-foot interval. When half the diameter of the caisson was covered, water suddenly oozed out from the caisson and the caisson sank to a depth of 6.7 m and the level of soil inside the caisson raised to a depth of about 7 m above excavated ground inside the well. The top of the caisson went under river water level. Fig. 1 shows the condition of the caisson before and after sinking. It can be seen from the figure that before sinking the caisson had a grip length of about 16 m (52 feet). Fortunately because of this grip length there was no tilting of the caisson and the sinking could be continued to desired depth despite the fact that top of the caisson went below river water level. Two important lessons were learnt from Buriganga. Adequate internal jetting arrangements should be provided for caissons where significant skin friction is likely to develop. If external jetting is to be used it should be done symmetrically so that uniform sinking takes place. One need not go for excessive removal of soil from within the open caisson without releasing skin frictional resistance in uniform manner.

Fig. 1. Position of caisson on Pier 17 of the Buriganga bridge before and after sudden sinking on September 1996.

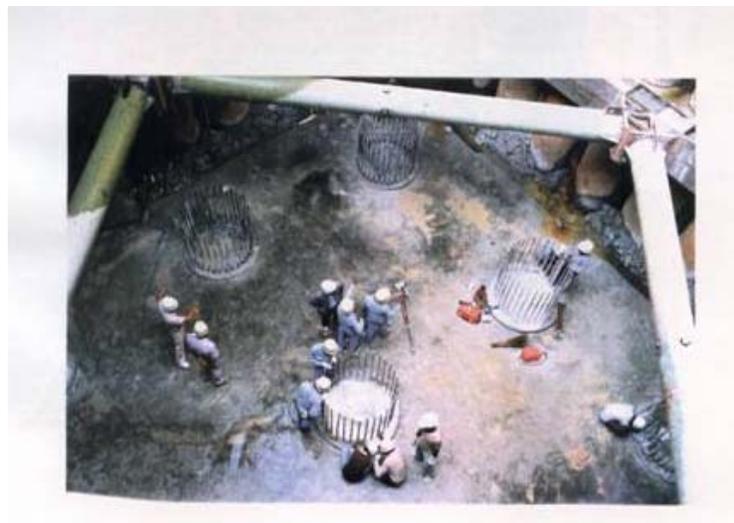
The Japan-Bangladesh Friendship Bridge over river Meghna is built on piers founded on bored piles. The construction of foundation at riverbed level required construction of a watertight cofferdam built with steel pipe piles (diameter: 1.016 m, length: 28.5 m) with vertical interlocking system. The cofferdam had to be braced with heavy steel pipes to resist external water pressure when inside is drained out. After installation of bored piles within the cofferdam, the inside had to be dewatered for excavation and preparation of bed for pile cap and pier. Fig. 2 shows pile head treatment for construction of pier within the cofferdam. Cast-in-situ concrete piles of 1.5m in diameter were constructed by using reverse circulation drilling method. Special measuring system was adopted for the vertical accuracy of the boreholes. The lengths of these piles are variable ranging from 40.0 m to 58.0 m depending on the level of the bearing strata for the piles.

Fig. 2. Pile head treatment for construction pier foundation inside the cofferdam.  
(Courtesy: Roads and Highway Department, Bangladesh)

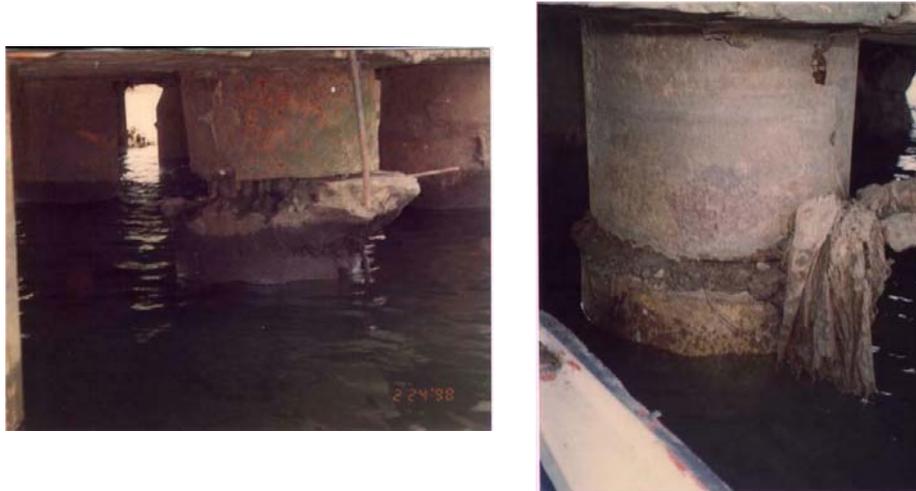
piles develop defect due to bad construction practice that relates to borehole formation, borehole cleaning and underwater or tremie concreting. Fig. 3 shows an example of bad concreting that developed within the piles just below pile cap for one of the pier of Dhaleshwari-1 Bridge. From the photograph it can be observed that there is discontinuity in the top casing where the concreting was affected.

Fig. 3. Photograph shows defective concrete work in the piles for Dhaleshwari-I Bridge.

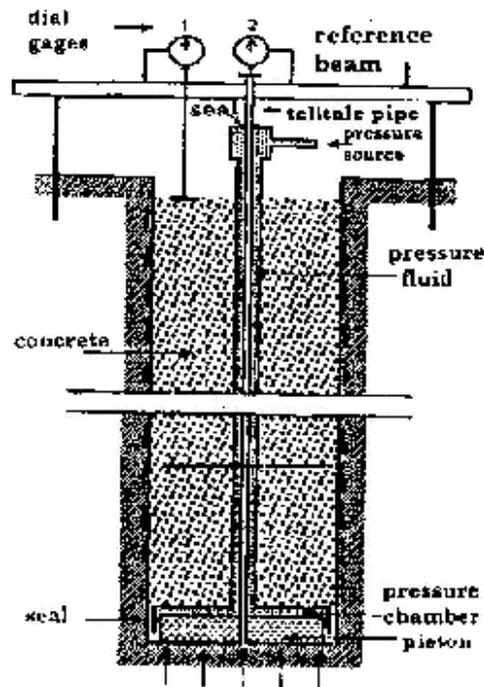
Fig. 4. Osterberg cell schematic

Invented and developed by Dr. J. Osterberg of Northwestern University, O-cell test for testing high capacity piles has changed the way foundation load tests are designed, performed and interpreted. The Osterberg Load Cell (also called O-cell) consists of a specially designed hydraulic jack capable of exerting very large loads at high internal pressures. Fig. 4 is a schematic diagram illustrating how the load cell works. A small amount of concrete is placed on the bottom of a bored pile hole after which the O-cell is lowered into the hole, which is then filled with concrete. A pipe welded to the top of the center of the cell extending to above ground surface acts as a conduit for applying fluid pressure to the previously calibrated cell. Inside the pipe is a smaller pipe connected to the bottom with an open end. It extends to the surface and emerges from the large pipe through an O-ring seal. This pipe acts as a telltale to measure the downward movement of the bottom of the cell as load is applied. The fluid for applying pressure can be oil or water. The liquid most often used is water with a small amount of miscible oil added to keep pump equipment from rusting. After the concrete has reached its desired strength, the cell is pressurized internally creating an upward force on the bottom of the shaft and an equal but opposite force in end bearing. As the pressure increases, the telltale moves downwards as the load in the end bearing increases and the shaft moves upward as the side shear on the shaft is mobilized. It should be noted that at all times the total side shear resistance above the O-cell is equal to the end bearing. Because of this no reaction

The downward movement is measured by dial gage 2, and the upward movement of the top of the concrete is measured by dial gage 1. Not shown on the figure is a pipe extending from top of the of the load cell to above the surface in which telltale rod that measures the upward movement of the top of the cell. Thus the difference between the measurement of this rod and dial gage 1 gives the compression of the concrete. From data obtained as the load is increased, the load-upward movement curves and the load-downward movement curves can be plotted. After the test is completed, the area below the bottom of the O-cell and the cell chamber can be grouted if the pile is to be used as a working pile.

For the largest capacity size O-cell (three feet diameter) the maximum force, which can be applied, is 3,000 tons up and 3,000 tons down. Details of testing procedure and interpretation of results can be referred to Osterberg (1999)<sup>4</sup>.

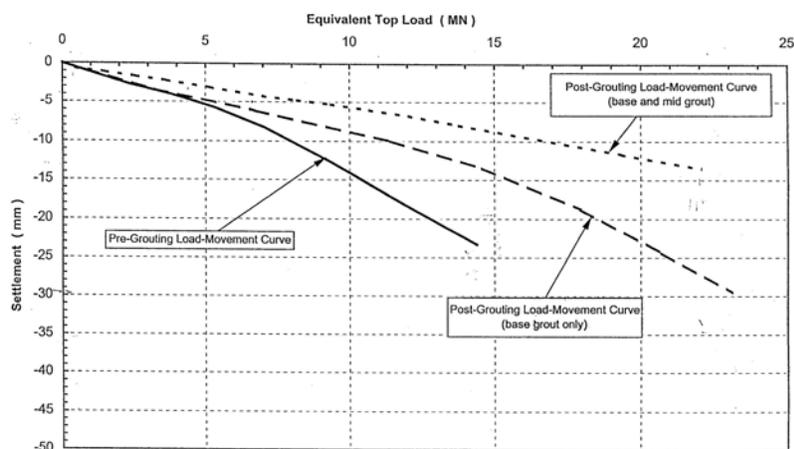
Fig. 5. Comparison of pre and post grouting capacity of test piles for Paksey Bridge as obtained by O-cell tests.

O-cell tests have been very useful in interpretation of skin-friction and end-bearing characteristics of large diameter bored piles used in three major bridges in Bangladesh such as the Bhairab Bridge, the Paksey Bridge and the Rupsa Bridge. It may be recalled that pile capacity in these bridges had to be increased by skin and base grouting as the un-grouted piles did not provide desired capacity required for design. Fig. 5 shows load-settlement relations for test piles used in Paksey bridge using O-cell test for condition of (1) no grouting, (2) base grouting only and (3) combination of skin and base grouting. The diameter for these piles was 1.6 m and the embedded length was about 70m. Using O-cell, load tests could be performed to a very high capacity. It can be seen from the test results that significant improvement in pile capacity in bored piles is possible in the granular deposits of Bangladesh. A specialist pile load-test contractor 'Load Test Inc.' performed all these tests.

Use of large diameter bored piles for three major bridges in Bangladesh has revealed that considerable improvement in pile capacity can be achieved by skin and base grouting techniques. Use of O-cell test has been very useful in interpreting pile capacity and deriving skin frictional resistance and base resistance of large diameter piles.

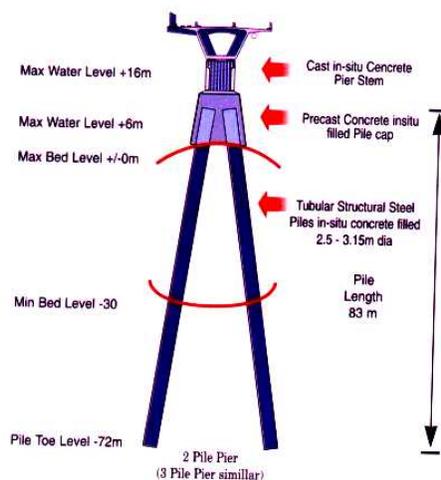
Fig. 6 shows typical 2-pile arrangement for pier support of the Bangabandhu Bridge. The tubular structural steel piles were originally supposed to be left empty inside, but later, the inside had to be removed of soil and filled with concrete except for bottom 5 m. of the tube. Grouting pipes were installed within the filled concrete and when the concrete had hardened, pressure grouting was done to improve the base soil inside the tube against any possible loose condition. Tappin et al (1998)<sup>5</sup> has described the construction of the Jamuna Bridge in Bangladesh.

Fig. 6. Typical 2-pile arrangement for Jamuna bridge piers.

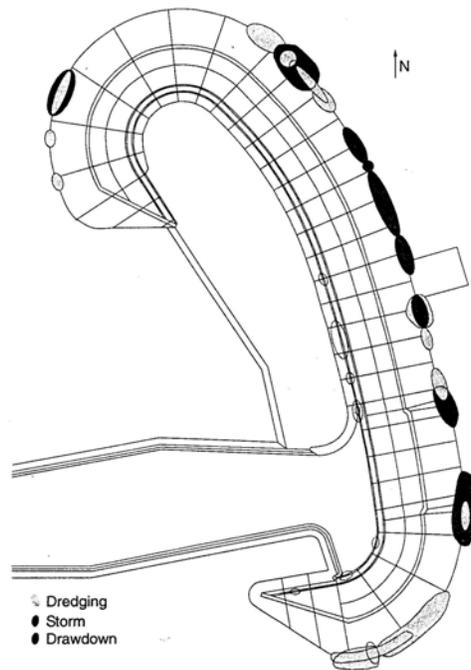
The West Guide Bund was constructed at the site of a rapidly formed island. The materials forming the dredged slopes consisted of young, rapidly deposited sand sediments. During its construction, a number of slips occurred in both the permanent and temporary unprotected slopes. A plan of the location of interest where the slips had occurred in both the permanent and temporary slopes while it was being dredged at original design slope of 1 in 3.5 are shown in Fig. 7. These slips represented approximately 50 % of the constructed length. At this time, the temporary slope being dredged at 1 in 3 slope was affected almost 100% of the dredged length. After the incidence a modification into the original designed slope was made which is shown in Fig.8. After the modification in the design profile was made, only three minor slips, representing less than 5% of the constructed length, occurred in the permanent slope when it was being dredged at 1 in 6 slope. In contrast, slips continued apace in temporary slopes, which was now at 1 in 5; these slips were associated with dredging, with storm activity, and draw down of river level. It is important to note marked difference in performance of the two slopes, at 1 in 6 and 1 in 5. Hight and Leroueil (2003)<sup>6</sup> provided a detailed account of this difference in behavior, which is described below.

The slips had the characteristics of underwater flow slides. Bathymetric surveys showed that, in plan, the slips had a classic hourglass shape, comprising a bowl-shaped depression from which the materials have been removed and an alluvial fan, where the slipped materials collected. In cross-section, the post failure profile was stepped and had a slope between 1 in 10 and 1 in 20. The failures took several hours to develop and involved between 50,000 and 100, 000 m<sup>3</sup> of material.

Fig.7. Plan on west guide bund to Jamuna bridge, showing locations of flow slides and trigger (Hight et al, 1999)

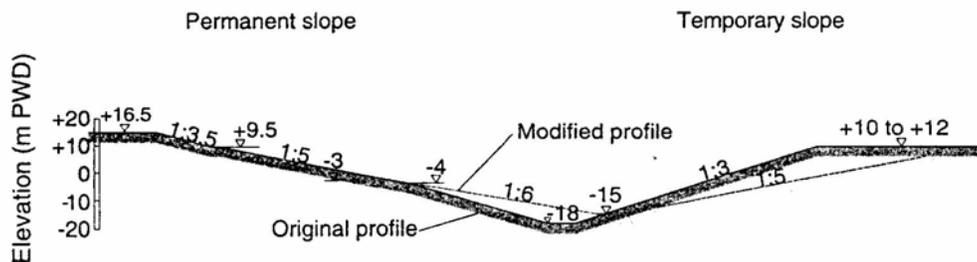
Fig. 8. Cross-section through west guide bund (Hight et al, 1999)
