# Seismic design and safety measures of the Otagirigawa (Phase II line) on the Joshin-Etsu expressway

**ABSTRACT:** The Otagirigawa bridge is located between the Myokokogen Interchange and the Nakago Interchange along the Joshin-Etsu expressway. Structural type of this bridge is designed as a steel reversed Lohse bridge which is the same type as the existing Phase I line bridge crossing parallel, because this bridge spans over a steep 50m-deep valley and it is necessary to consider the workability taken into the impact on the existing Phase I roadway, economy, landscape etc. This bridge is designed towards increased seismic resilience utilizing buckling restraint bracing, and increased maintenance related performance. For erection of this bridge, the end spans were built using a lateral transfer single-operation erection method, while the central span was built using diagonal suspension method using temporary cables and traveler cranes. There is the existing Phase I roadway with offset distance of only 165cm to the side of the erection point, and there is a high-voltage transmission lines and underground gas pipes to the west. For this reason, Safety measures for the erection in c

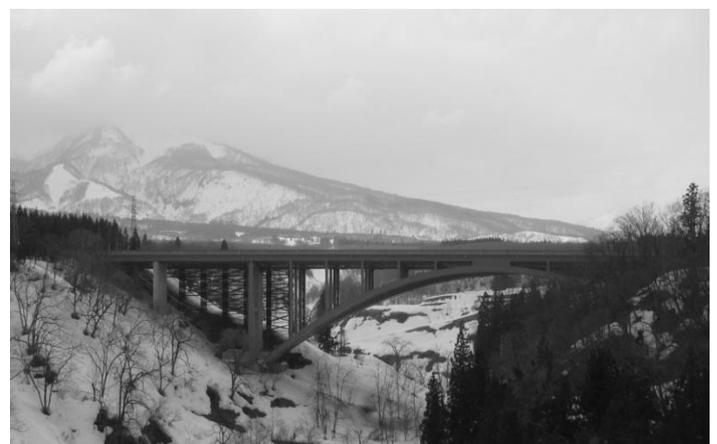
Figure 3. View of Otagirigawa bridge from National Route 18.

In addition, we confirmed the silhouettes facing Mt. Myoko from the National Highway Route 18 running in parallel with the Joshin-Etsu expressway in several perspectives, and aligned the arch curves and vertical materials on the A-A1 side with the Phase I line bridge (Figure 3).

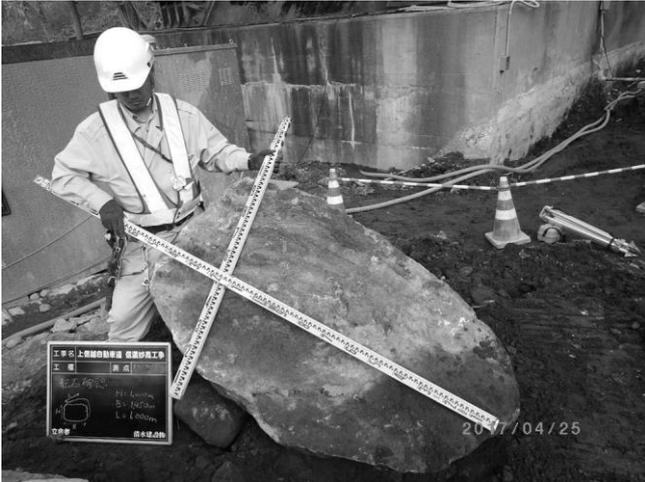
Figure 9. The distribution of the maximum axial strain generated. Figure 10. Installed snow fence.

Although the influence on the Phase I line bridge basis was reduced and the chemical solution was grouted for the hole wall protection of earth retaining, it took time to process debris flow with boulders exceeding  $\phi 1.0\text{m}$  and pyroclastic flow deposits (Figure 9). Furthermore, the hole wall for inserting the H steel of the retaining pile was not self-supporting due to the large amount of groundwater, and the construction was performed with a down-the-hole hammer that also used a casing. The process delay due to boulders processing became the performing the substructure construction in the snow season, cover the entire arch abutment around and piers in thermal insulation sheets, the snow fence were placed each two jet heater organaizing to cold weather construction (Figure 10).

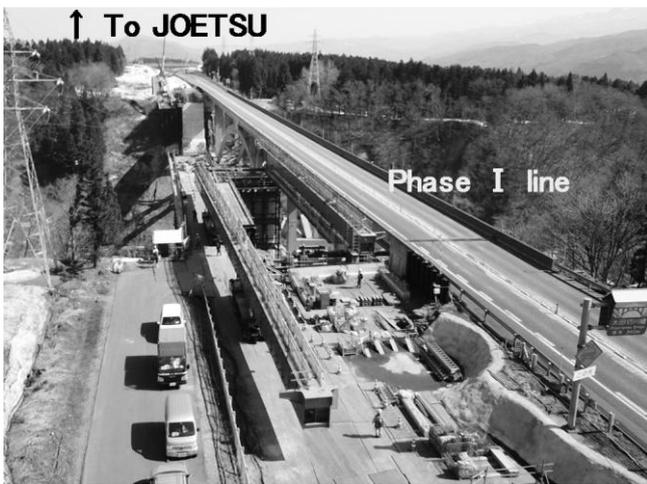
Figure 11. Transportation by multi-axle trolley.

At first, the construction of the side span was planned to install a truck crane vent using a temporary pier. However, the boulders delayed the construction period of the lower part, and the vent was to be installed on steep slopes where the construction period was expected to be longer. We decided to avoid it. In addition, since the construction of the girder was required to be completed by the time of the snowfall, a single-operation erection method with a multi-axle bogie was adopted from a temporary pier that can be constructed in a short period of time during the winter (remaining snowy season) (Figure 11).

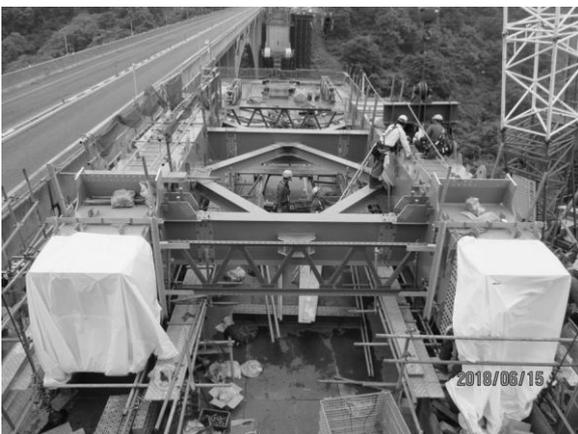
Figure 16. Suspended by the two erection cable.

Also, in the case of single-material erection, the possibility that the suspended load rotates and protrudes to Phase I line side increases. Therefore, the panel is assembled in the loading yard (on the span on the A2 side). It was planned to be suspended by the two erection cables (Figure 16, 17).

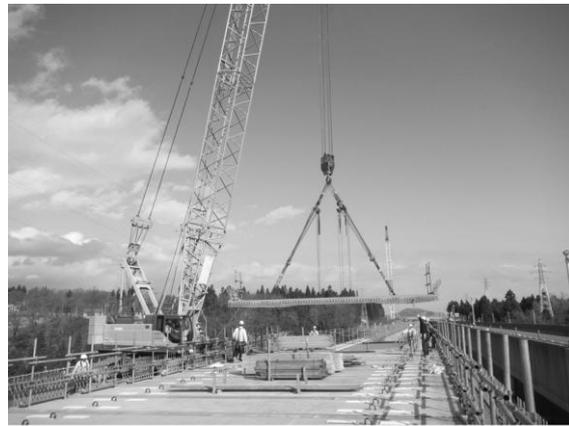
Figure 19. Floor slab erection.

After erection of the arch girder complete, It was necessary to make effective use of short period until the snow for the slab construction. The precast PC slab was adopted in the scope perfection capable of both sides side span from the temporary pier, shortening the construction period (Figure 19). The size of the precast PC slab was 2,000 mm in width in the bridge axial direction and 9,900 mm in width at rectangular direction. 31 slabs were used on the A1 side and 16 slabs were used on the A2 side. The joint structure between the PC versions was a jawless RC loop joint.

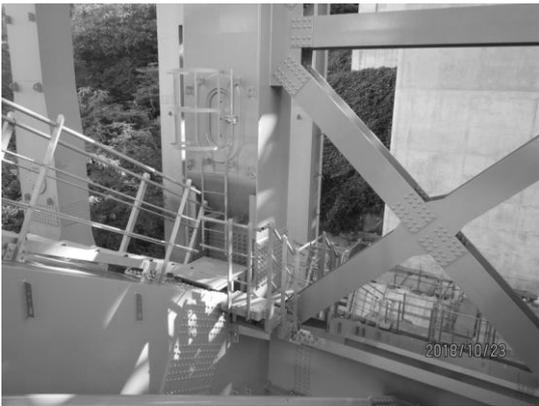
Figure 20. Inspection road of superstructure.

Since this bridge is classified as a special bridge, various considerations were made in view of the future maintenance stage. Inspections road, zinc-aluminum alloy plating with high anticorrosion performance was adopted because corrosion was confirmed on the Inspections road of the Phase I line bridge. Important inspection points such as the points and attachments between the arch ribs and the vertical material, the locations where mechanical meters are installed, and the access to parts inside the arch ribs are wide inspections roads (Figure 20), and large bridge inspection vehicles are used. An Inspections path was also provided under the overhanging slab around the median strip before and after the arch crown where it would be difficult to inspection even if used (Figure 21).

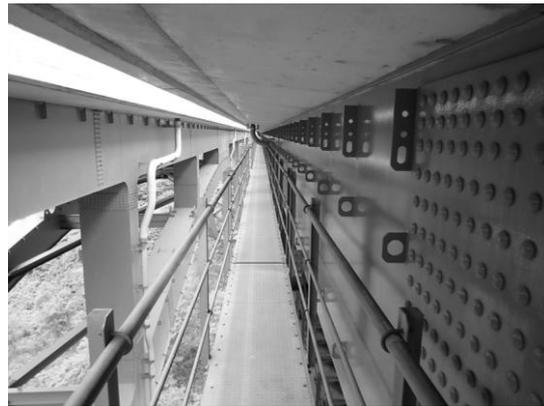
Figure 21. Inspection road of arch crown.

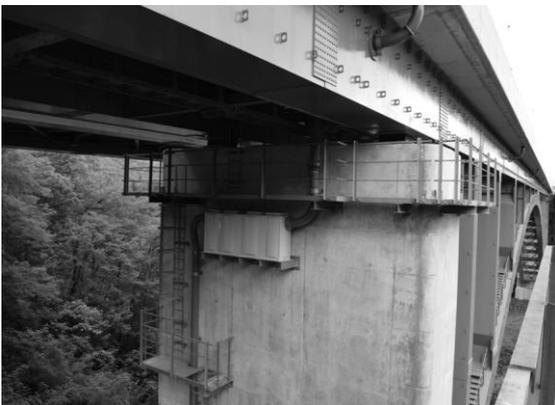
Figure 22. The oil/water separator on the pier.

In addition, when the oil spill from the accident vehicle or the like, oil-water separation basin to prevent the oil to a off highway flows out, access review the installation of on difficult steep slopes. Installing at the pier side substructure inspections road by installing directly underneath and making the sidewalk of the inspections road openable, the access from the road surface and the cleaning and inspection of the oil / water separator are facilitated (Figure 22).

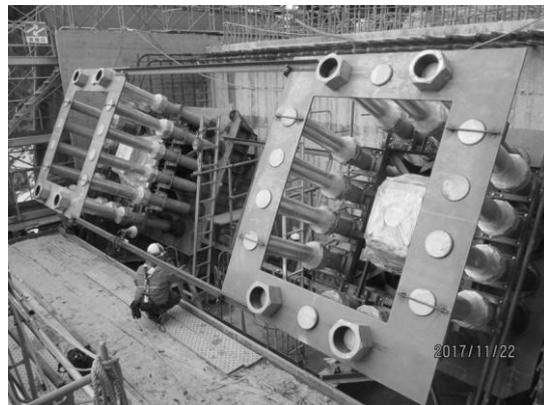
Figure 23. Arch-base anchor bolts with hot-dip galvanized.

The anchor bolts at the base of the arch are very difficult to replace. Therefore, antirust is applied to the objectives by hot-dip galvanizing (Figure 23), and the completed fixed later is covered with a protective cap. The durability was improved by filling with epoxy resin in order to make cap and bolt adhere (Figure 24). At the end, dead leaves and other deposits were confirmed at the base of the arch of the Phase I line bridge, so a roof was provided for protection (Figure 25).

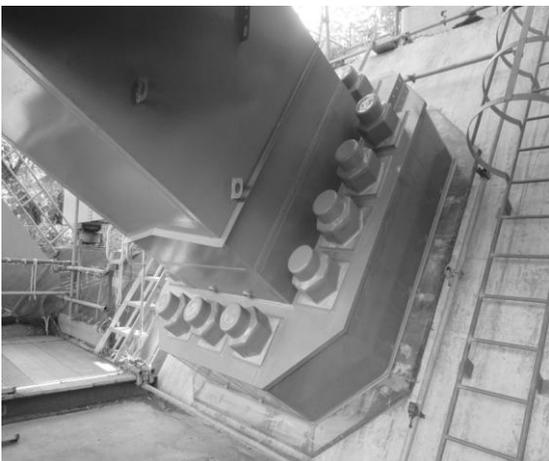
Figure 24. Arch base for improved durability.

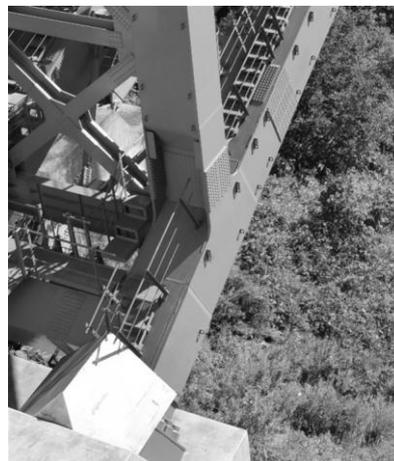
Figure 25. Arch base roof.
