# Repair method for corroded steel girder ends using CFRP sheet

**ABSTRACT:** Loss of cross section owing to corrosion is a primary factor in the deterioration of steel bridges. Therefore, carbon fiber-reinforced plastic (CFRP) sheet has attracted attention as a material for repairing and reinforcing steel bridges because of its light weight, high strength, and superior durability. Although many studies have been published relating to this topic, previous studies have primarily focused on the application of CFRP to axial or bending members. However, most of the corrosion is found on the webs or columns at the ends of the main girders. Few investigations have examined repairing corroded webs or columns using CFRP sheet. In this research, a shear buckling test for steel girders and a uniaxial compression test for cruciform columns are conducted to develop a repair method for corroded steel girder ends using CFRP sheet. In this method, low elastic putty layers are inserted between steel and CFRP sheets to improve the performance of out-of-plane deformation.

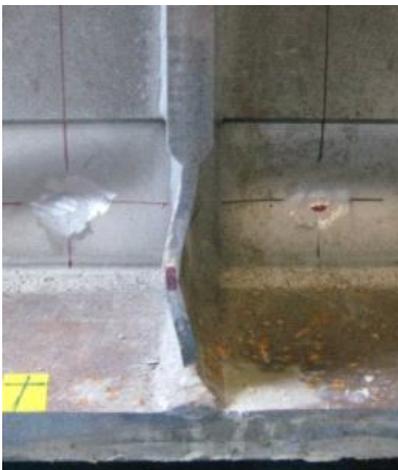
Figure 2. Local Buckling at Vertical Stiffener

When corroded vertical stiffeners or webs are in an ultimate state, local or shear buckling might occur under compression or shear, as shown in Figure 2 and Figure 3. Thus far, it has not been reported whether CFRP bonded on these members can adapt to large deformations and recover the initial performance of the members. Therefore, we studied the constitution of the adhesion layer that will prevent the delamination of CFRP caused by buckling. Our previous study confirmed that inserting polyurea putty, which has a low elastic modulus (55–75 MPa) and high elongation (300–500%), between the steel plate and CFRP sheet can help prevent delamination under large deformations. In this study, it is difficult to acquire material properties from non-tensile tests because elongation at the break is excessively high. A high modulus carbon fiber sheet, with Young's modulus of 640 GPa, displayed the best repair efficiency among the various FRP sheets tested. Therefore, we propose a repair method for corroded vertical stiffeners and webs at steel girder ends using CFRP sheets, as shown in Figure 4. In the following sections, we will report on the practical design method and the results of experiments conducted to confirm its validity.

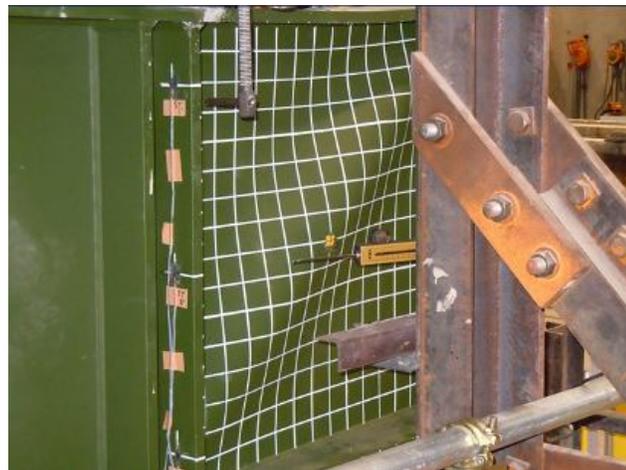
Figure 3. Shear Buckling at Webs
