Seismic rehabilitation of masonry structure strengthening by two distinct FRPs

ABSTRACT: Huge losses on both human lives and properties from the recent earthquake in Nepal, demonstrate the need for strengthening of masonry structure due to their poor seismic performance posed by their inherent brittleness and low tensile strength. This paper investigates the in-plane shear performance of externally strengthened masonry walls using two types of fiber reinforced polymer (FRP) sheets, they are- artificial FRPs such as CFRP and PET-FRP which are relatively expensive FRPs have been used in conjunction with low-cost FRPs made from natural fiber such as JUTE and COTTON fiber. An experimental research program was undertaken, in which brick masonry walls were tested for static loading after installing PET-FRP, CFRP, JUTE-FRP and COTTON-FRP sheets on their surface in three different configurations. The results demonstrate that a significant increase in the in-plane shear capacity of masonry can be achieved by bonding those FRP sheets to the surface of the walls.

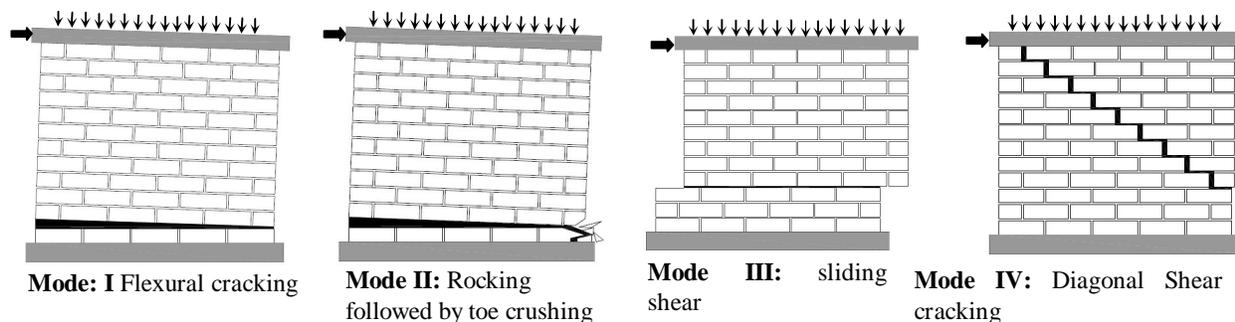
Figure 1. Different Failure modes of URM

The lateral shear strength of a URM wall depends on the failure mode of the wall, which is governed by a number of variable parameters, such as masonry aspect ratio (L/H), vertical compression on the masonry (σ_n), compressive strength of the masonry (f_{mc}), tensile strength (f_{tu}), shear strength (τ_u), masonry elastic modulus (E_{me}), and masonry shear modulus (G_{me}). These variables control the inelastic mode of failure of masonry shear walls. The lateral strength of masonry shear walls is limited by flexural cracking, rocking followed by toe crushing, diagonal shear cracking, and sliding shear at the bed-joint (see Fig. 1). It should be noted that not all these failure modes will involve collapsing of the masonry shear wall, and the final failure may be a combination of several failure modes. A more general way of representing the various failure modes of masonry shear wall is given by Drysdale and Hamid (2008) as seen in Fig. 2, where the interactions between normal and shear

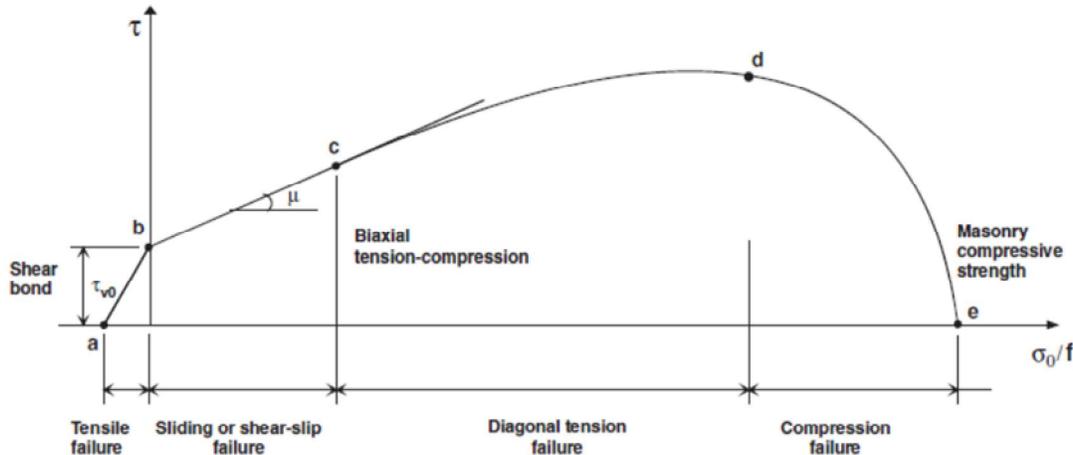
Figure 2. Behavior of URM under combined shear and normal stress (Drysdale et.al. 1994)

stresses on the masonry bed joints are shown. It is evident in Fig. 2 that the modes of failure in masonry shear wall are generally dictated by the magnitude of vertical compression force applied over the wall. However, a rationally developed failure criteria should be able to predict the tensile, compressive and shear types of failure (Zhuge et al. 1998).

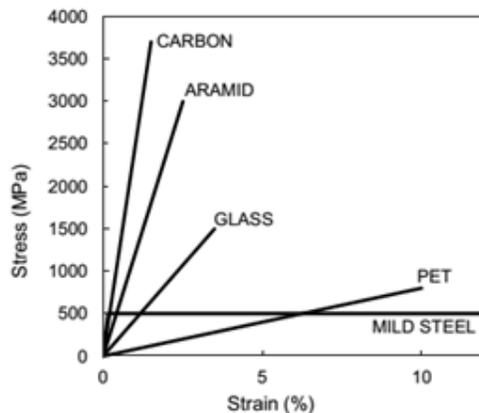
Figure 3. Tensile strength of different FRPs

Externally bonded PET-FRP with a large fracturing strain is a retrofitting technique that has drawn significant attention as a unique alternative to CFRP or GFRP (Fig. 3). This is due to its pronounced failure strain and relatively low material cost, without compromising the other advantages of FRP. The main objective of using FRPs is to enhance performance of a structure at normal loading conditions and to offer greater resistance at the times of severe loading. Neither too much stiffness nor very high strength materials will be coherent with

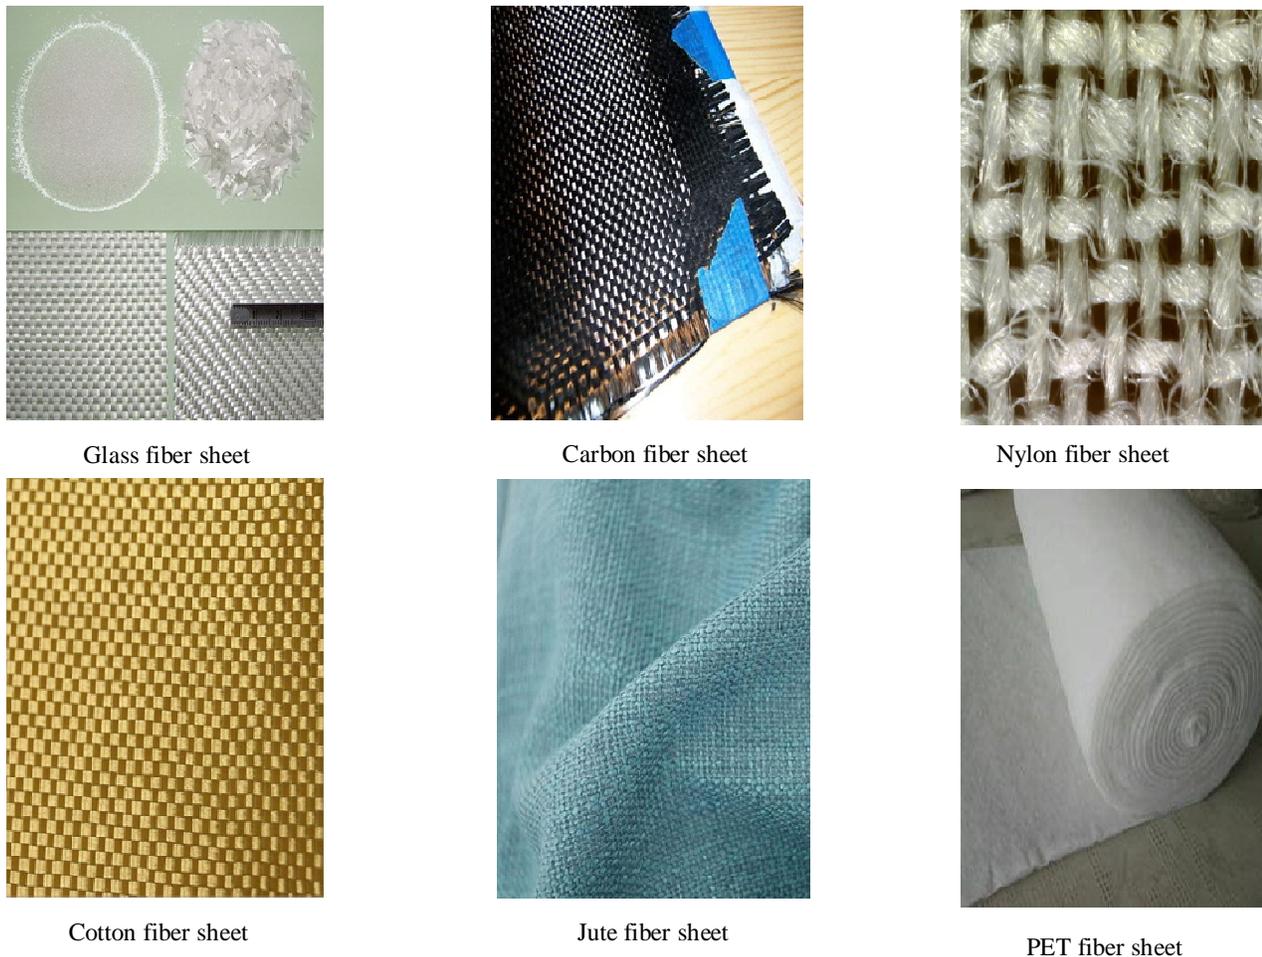
Figure 4. Common types of fiber sheet

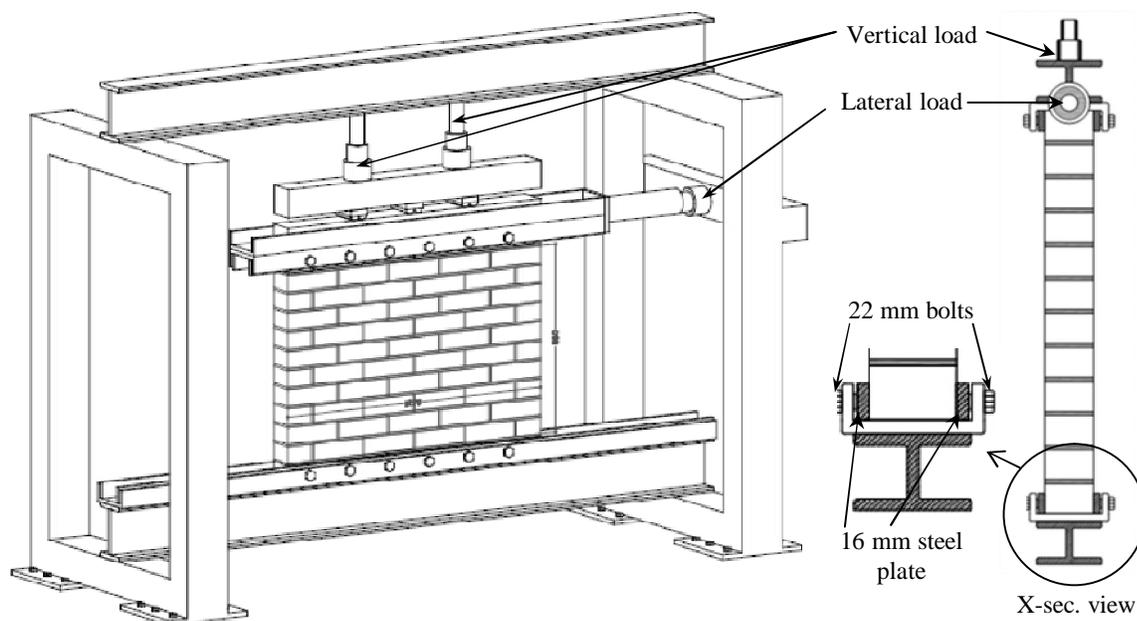
Figure 5. Schematic diagram of experimental setup of shear wall

After the required curing period, the wall was transferred to the testing frame. The wall top and bottom were anchored to the top and bottom channel beams, with the help of twelve 22 mm bolts as shown in Fig. 5. Between the wall and the side of the channel beam, a 16mm thick steel plate was inserted so that pressure could be applied on the wall by tightening the bolts. Gypsum plaster was used to fill a gap between the wall and the steel plate. For FRP strengthened walls, the FRP itself was wrapped in a U-shape anchorage, so there was almost no chance of slippage of the FRP during the experiment. Although this kind of anchorage system is not very much practical for the real structure, it has been chosen for this experimentation to avoid premature anchorage failure of FRP prior to attaining full shear strength. A pre-compression of 38 kN which is equivalent to uniform pressure of 0.25MPa, was applied on the top of the wall through two hydraulic jacks, prior to the shear loading to simulate the load of the structural component coming on the wall from above in the real structure. These two vertical loads restricted the rotation of the top beam only to some extent, as the beam was not restrained against rotation during the evolution of lateral load.

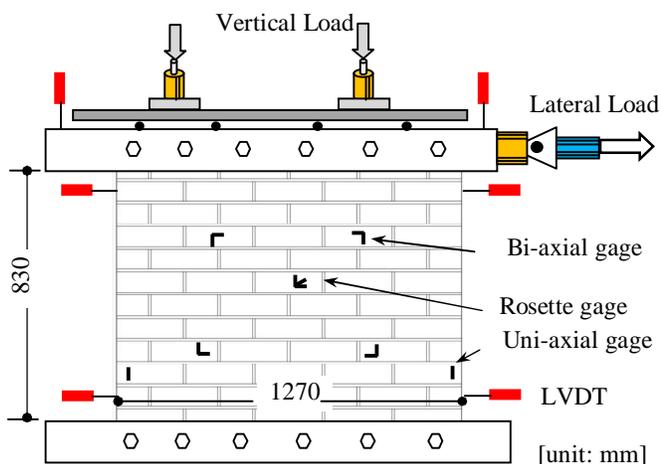
Figure 6. Instrumentation of control wall RWS

Sufficient uni-axial, bi-axial and rosette strain gages, LVDTs, and load cells (50 tons capacity) were used to record all the necessary information during the testing. A lateral load was applied in a pull-out manner by a 50-ton capacity center-hole jack, with a remote pump, until the complete failure of the masonry wall. A universal coupling-joint was used to minimize the effect of bending due to rotation of the top beam during the evolution of loading. All of the data (displacement, strain, and load) were recorded through a digital data logger. Fig. 6 shows the instrumentation of a typical shear wall.

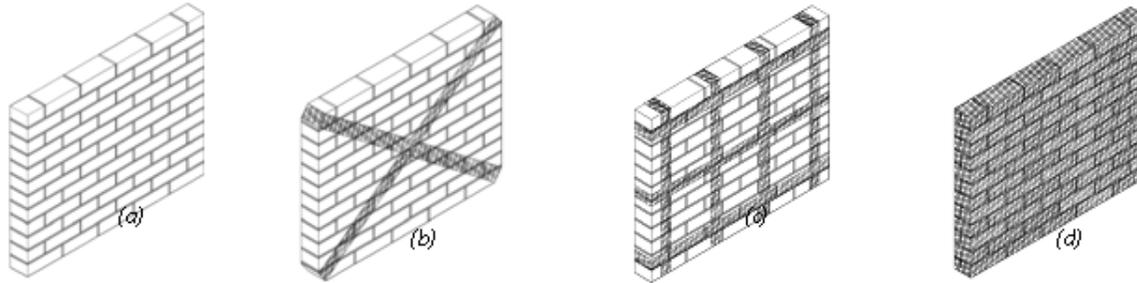
Figure 7. Wrapping technique of masonry wall by FRP, (a) Control wall(RWS); (b) FRP diagonal bracing (CSD, PSD); (c) FRP strips in grid system (CSG, PSG); (d) Fully wrapped by FRP (CSF, PSF)

FRP sheets having unidirectional fibers, were applied using a wet layup procedure on wall specimens in three different configurations as shown in Fig. 7. At first, the wall specimens were cleaned by removing loose mortar and dirt with the help of a wire brush. Epoxy putty (filler) was used to fill the depression on the wall surface to provide a smooth plane surface ready for FRP laying. A thin layer of primer was then applied all over the wall

to seal the pores in the masonry so that the subsequent application of epoxy resin would not be absorbed. Epoxy resin having the properties indicated in Table 1 was then applied over the wall wherever necessary. Fiber sheets were cut to the length and width needed to cover approximately 20%, 40% and 100% of the wall gross area (see Fig. 7). Resin was then applied with a roller brush all over the sheet strip so that it was fully saturated by the resin. As soon as the application of the resin was completed, the FRP strips were laid over the wall and wrapped tightly to keep them in place. For the diagonal strip, the wall corners were cut in the same dimension width (80 mm) as the strip [see Fig. 7(b)] in order to avoid sharp edges and problem in wrapping.

These walls were strengthened with FRP strips of 70 mm width each in a grid system as shown in Fig. 7(c) which covered approximately 40% of the gross wall surface.

These walls were strengthened by fully wrapping with FRP sheets according to Fig. 7(d). For CSF, the stiffness as well as the lateral load capacity was so high that the grip at the wall bottom prematurely failed before the wall attained its full strength. The wall PSF1 showed a high initial stiffness due to a higher percentage of PET, and remained unchanged until it reached about 60% of its peak shear capacity. Only after that, did the stiffness show a softening tendency, but no damage or crack whatsoever was seen on the wall, as the wall was fully covered by the PET-FRP sheets. Once it reached its full strength, further displacement only resulted in load reduction. It was observed that the wall was coming out from the grips at the bottom. The experiment was terminated at that point because it was impossible to continue as both the wall and jack were out of plane. For PSF2, similar phenomenon was happened at a load of 50 kN and the load raised to 160 kN. For wall strengthened by JUTE-FRP, a ductile load-deformation behavior can be seen in Fig. 12 with an ultimate load of 104 kN (see Table 1). On the other hand wall reinforced by COTTON-FRP (see Fig. 14) also show more ductile behavior than its counterpart CFRP or PET-FRP wall. Since all these walls were fully wrapped by the FRP sheets, damage, if any, could hardly be detected by visual observation.

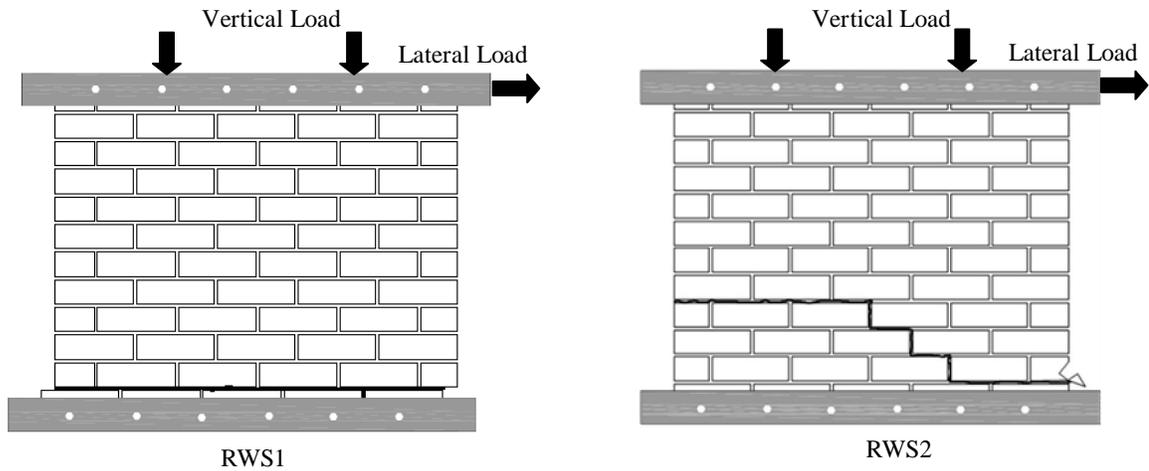
Figure 8. Schematic illustration of crack in RWS

These reference walls were tested under physical and boundary conditions similar to those of the rest of the walls mentioned in Table 2. In the case of wall RWS1, when the lateral load reached 42 kN, a flexural crack appeared at the heel of the wall, and propagated towards the toe as shown in Fig. 10, and the load dropped slightly. Lateral load was further increased to 45 kN, and the crack opening widened as the crack propagated all the way to the toe of the wall. No crushing was observed at the toe. After the applied load reached its peak, it did not decrease much with the increased displacement, which furthered the shear-slip along the crack plane as shown in Fig. 8. Similar crack pattern was observed on the wall RWS2. When the lateral load reach about 23 kN, a flexural crack appeared on the wall heel as shown in Fig. 8, and the load dropped to 19 kN. Lateral load was further increase to 30 kN, and the crack further propagated almost halfway the length of the wall and took a downturn in a stepped fashion and travelled all the way to the toe of the wall. During this evolution of crack, no significant degradation of load was observed rather the crack opening widened and a faster crushing at the wall toe was observed which caused a rapid decrease in load. This kind of failure in URM wall under shear is reported in a number of papers (Stratford et al. 2004; Salmanpour et al. 2013; Bosiljkov et al. 2003; ElGawady et al. 2007 etc).

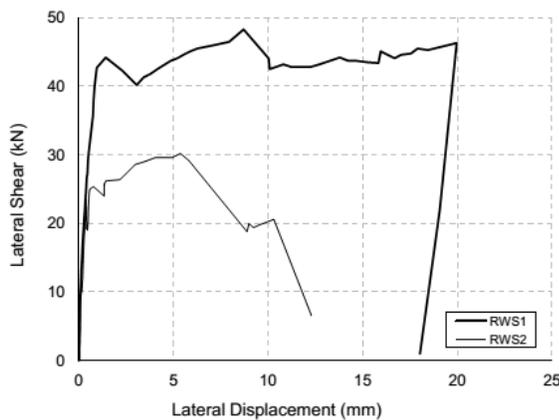
Figure 9. Load-displacement response of RWS

The load-deformation characteristics of RWS are given in Fig. 9. It is quite evident from the figure that, before appearance of any potential flexural crack, the load-deformation relationship is quite linear. As the first crack appeared at the wall heel, the load dropped by a little and could still undergo shear deformation with substantial resistance in a manner that can be characterized as elasto-plastic behavior. This post peak behavior may be dependent on the mortar interface shear behavior with residual stress (Rahman and Ueda 2014), which did not diminish with applied displacement. If flexural cracking is followed by toe crushing, a softening in post-peak load is generally observed as in the case of RWS2. So, it can be said that a premature flexural cracks normally followed by either a toe crushing or a sliding shear type of failure. For slender walls, rocking type of failure is usually seen in many experimental shear walls.

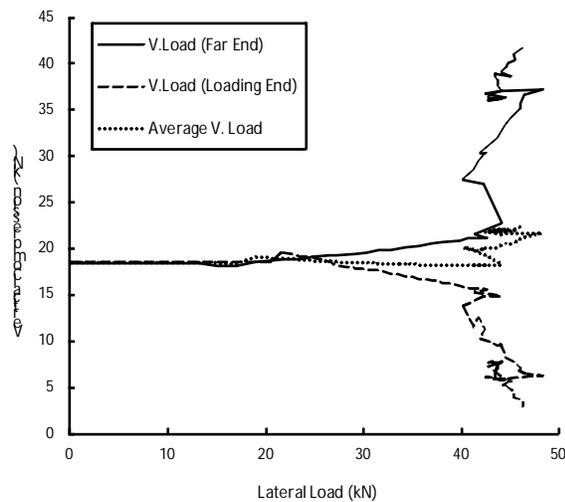
Figure 10. Variation of vertical load with progressive shear

Fig. 10 shows the variation of vertical pre-compression with the progress of lateral load. It is evident from Fig. 10 that the vertical load on the far-end increased with the progressive shear, while the vertical load went down on loaded-end. This is due to the fact that, with the increase of lateral load, the top beam on the wall underwent a small rotation, which exerted a vertical upward pressure on the far-end jack on the wall. However,

the average vertical load (broken line in Fig. 10) did not change much from the initial stipulated value of 19 kN.

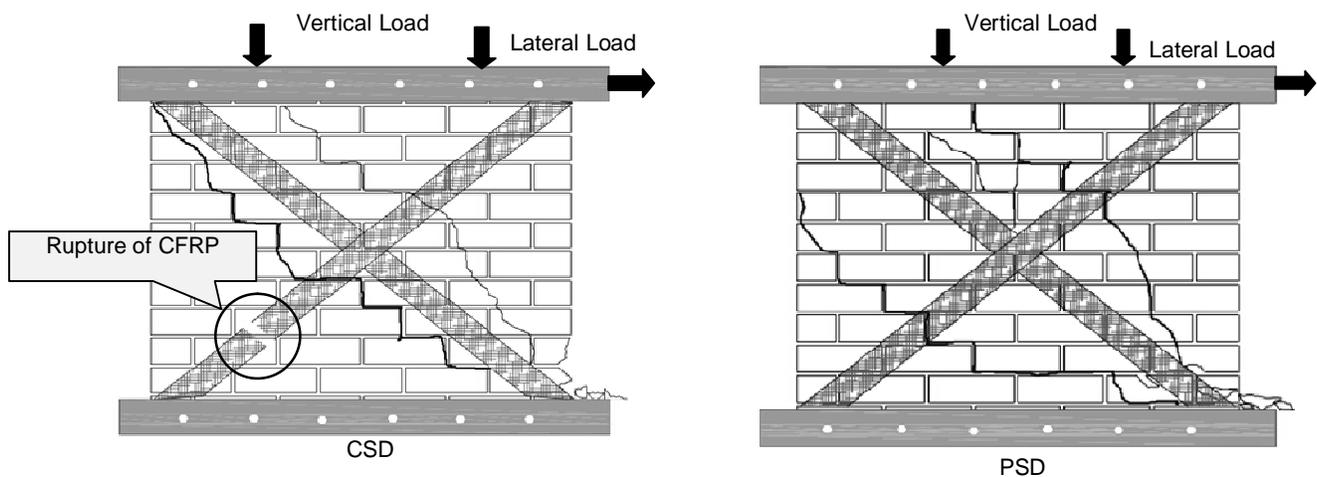
Figure 11. Schematic illustration of crack in diagonally FRP braced shear wall

These walls were externally reinforced by two diagonal FRP strips each, of 80 mm in width in a fashion shown in Fig. 6(b), which covered approximately 20% of the gross wall surface. In the case of the wall with CFRP strips (CSD1), at a load of 76 kN, two flexural cracks appeared at the wall top on the loading end and at the wall bottom on the far end (see Fig.11) followed by some debonding of the CFRP tension diagonals. No rupture or damage of the CFRP was observed. For wall CSD2, the initially stiffness was similar to that CSD1, but at a load of 75 kN, some fine line cracks appeared at the top of the wall on far end and started to propagate downward in a stepped fashion. Once the load increased to a maximum of 94 kN, a sudden rupture of the diagonal tension strip on the both sides of the wall took place and the load suddenly dropped to the half of the peak load. Accumulated compressive stress caused a complete failure at wall toe just before the rupture of the CFRP strip which can be seen Fig. 11.

In the case of the wall reinforced with PET-FRP strips (PSD1 and PSD2), similar crack patterns were observed on these two walls and they were stepped diagonal shear crack followed by some toe crushing(see Fig. 11). The peak load of 114kN and 101 kN respectively did not attenuated much with the applied displacement for quite a long time, and at that stage the experiment was ceased.

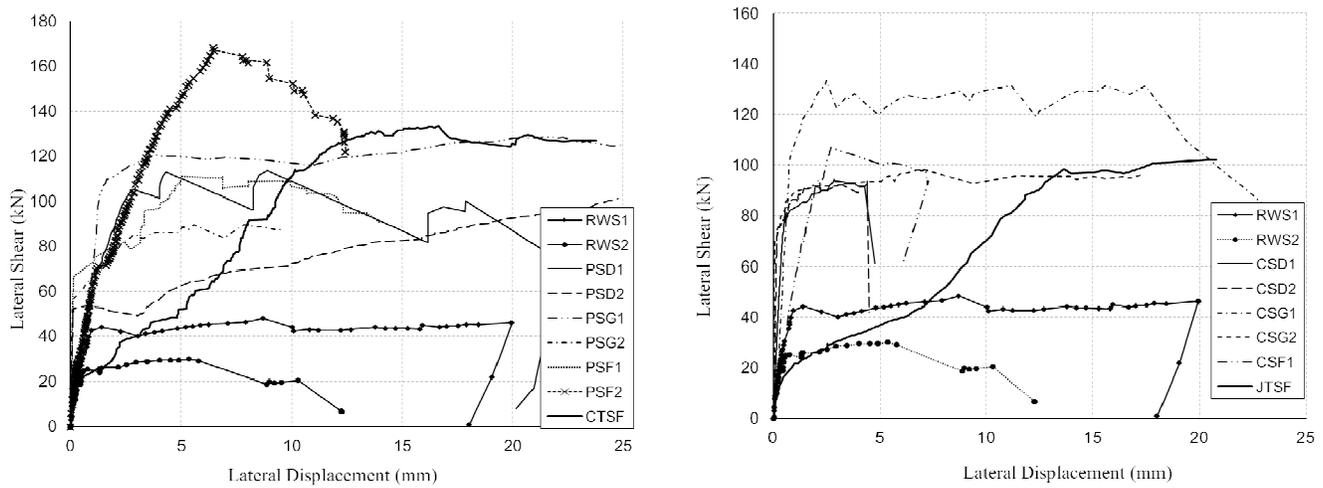
Figure 12. Load-deformation envelopes of all URM and FRP reinforced shear walls

The load-deformation characteristics of all of the FRP reinforced walls are given in Fig. 12. It is obvious in these two figures that the shear capacity of PET-FRP strengthened walls are little higher than their counterpart

of CFRP strengthened walls but the deformation at peak load for the case of PSD is much higher than that of CSD. From ductility point of view, wall strengthened with PET-FRP behaves in a more ductile manner than CFRP strengthened wall as no rupture of FRP was observed in PSD walls. Moreover, unlike CSD, for the case of PET-FRP strengthened walls, the load did not drop much after reaching its full strength and a ductile mode of behavior can be seen in the post peak regime. In comparison with URM walls, both CSD and PSD walls have as much as twice the shear strength than URM walls. On the other hand PSD walls show similar ductile nature of URM walls but CSD walls are quite brittle and had lesser shear deformation at peak load than URM walls.

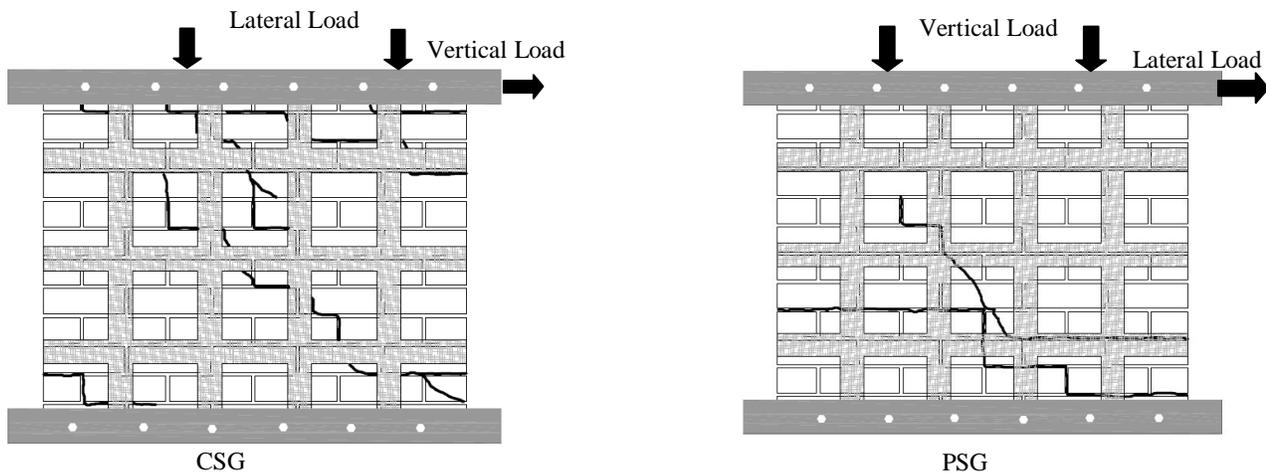
Figure 13. Schematic representation of crack in shear walls strengthened by FRP grid system

In the case of the CFRP reinforced wall (CSG1), some fine-line diagonal cracks appear at the central area of the wall. It was not long after this, that more cracks appeared across the tension diagonal with simultaneous debonding of the CFRP strips, the load reached a level of 130 kN (Fig. 13). Almost simultaneously, one of the horizontal CFRP strips ruptured with a loud explosive sound, and the load dropped to 109 kN. With further displacement, the crack width increased and, in some places, the CFRP totally separated from the wall. Cracks of similar nature were observed on wall CSG2 as well, with the only exception is that the peak load was limited to 99 kN and no rupture of CFRP was noticed.

On the other hand, the walls PSG1 and PSG2, strengthened with PET-FRP, showed less stiffness than its counterpart, CFRP. For PSG1, at a load of about 120 kN, some debonding of the PET-FRP strip occurred along the tension diagonal. Almost simultaneously, a flexural crack followed by some discontinuous diagonal cracking appeared at the lower half of the wall on the heel side, and travelled all the way to the wall toe in a stepped fashion as shown in Fig. 13. With further displacement, the load remained almost constant but the wall slipped forward along the crack path and the experiment was terminated at that stage. Similar crack pattern was also observed in wall PSG2 as shown in Fig. 13 in a lesser degree and the peak load was limited to 88 kN. The comparison of lateral load-deformation response between PET-FRP and CFRP retrofitted walls is given in Fig. 12. Regarding ultimate load, both walls have similar shear capacities but PET-FRP behaves in a more ductile manner than CFRP. The mode of failure of those four walls look similar to each other and they are predominantly flexural cracking followed by diagonal shear slipping. Comparing with URM walls, both the two types of walls have shear capacity as much as three times higher than the URM walls. Walls when strengthening with PET-FRP grid system, the ductility is not compromised much in comparison with URM walls but for the case of CFRP strengthened wall ductility is reduced to almost half of the URM walls. It is also interesting to note that the ductility is not compromised substantially when the walls are strengthened with higher amount of FRP such as grid system than the amount of FRP in diagonal configuration. This phenomenon holds true for both PET-FRP and CFRP strengthened walls.

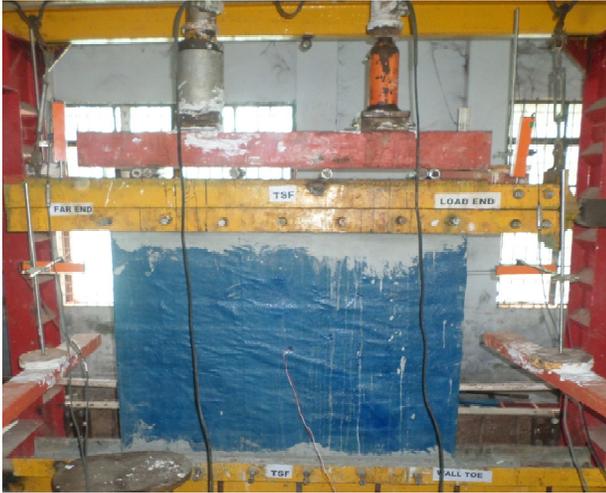
Figure 14. Experimental setup of COTTON-FRP reinforced shear wall

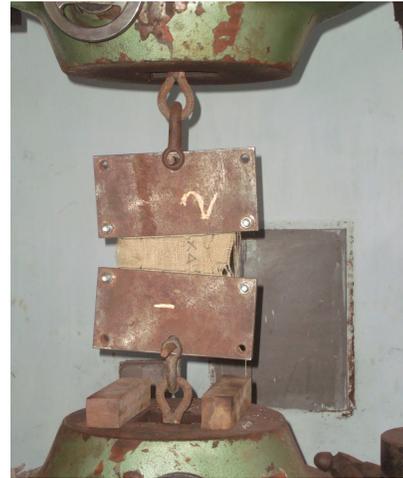
Figure 15. Experimental setup of tension test of JUTE sheet
