Analysis and repair of sliding material in large movable bearings for long-span bridges

M. Moriaki & S. Osako

Honshu-Shikoku Bridge Expressway, Co., Ltd., Kobe, Japan

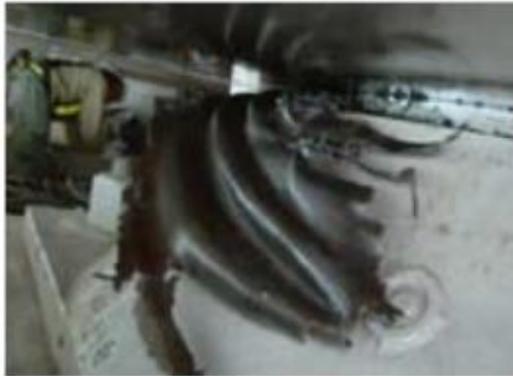
Picture1. Damage of Movable Bearing

The protruded sliding plate is shown in Picture 1, and the photo obtained during the examination by an electron microscope is shown in Picture 2. The upper surface of the protruded PTFE plates (the sliding surface) was smooth, whereas the bottom surface showed a fibrous aspect in the extension direction. It seems that the material was rolled out by the friction force created by the expansion of the bridge superstructure.

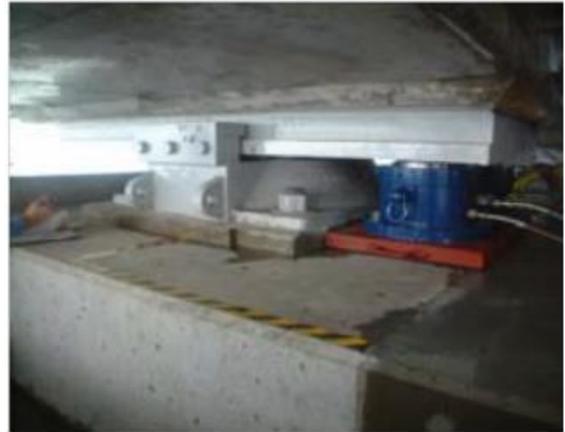
Figure 6. New bearing structure for replaceable

PTFE plate. The PTFE edges of the new structure are chamfered to control flange forming, and an epoxy adhesive, which adhesion strength was verified, was used for the PTFE and the thin steel plates. In order to ensure safety if adhesion is gone, the PTFE is inserted in a digging-in section of the thin steel plate, (see Figure-6(a)).

(a) Structure for replaceable

(b) Replacing

In order to avoid modification in the bearing height as much as possible, the structural steel plate thickness shall be 6mm or 9mm as standard. The PTFE plate diameter shall be as similar as possible to the one of the steel plate. The steel plates have notches in the proper positions that make them a replaceable structure.

Based on the results of the performance verification tests, the removal of the existing sliding plate and its replacement by the new sliding plate was conducted in the existing bridge (see Figure 6(b)). The conducted work verified the simplicity of the replacement strategy.

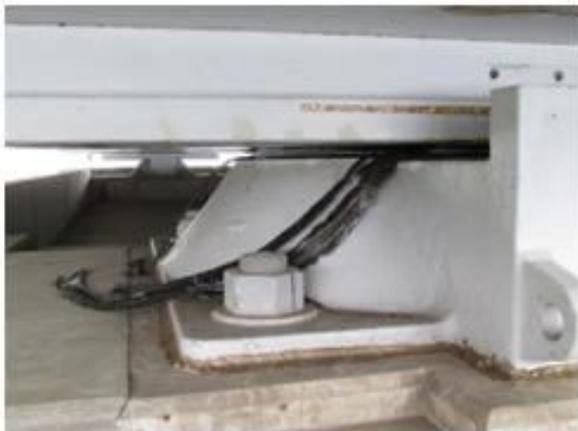
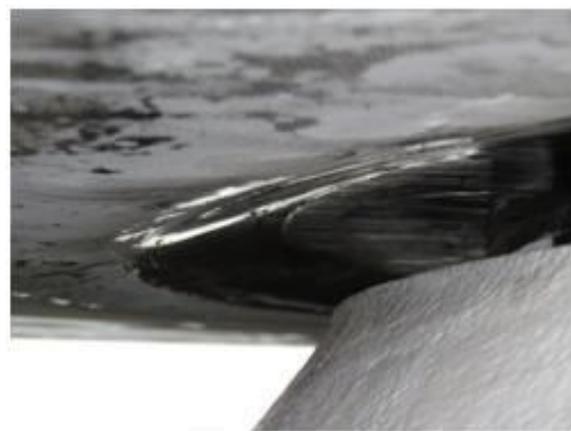
Picture 3. Re-Damage of Movable Bearing

The protruded sliding plate is shown in Picture-3. It presents a fractured surface that seems torn off in crescent shape, and the surface was pushed to the side intermittently.

- The sliding plate dimension ($\phi 950\text{mm}$) was larger than those used for other bridges. This led to stress concentration on the edges of the sliding plate by the scale effect.
- The dead load reaction force (surface pressure 26N/mm^2) and ordinary displacement ($\pm 250\text{mm}$) were larger than those for other bridges, which was detrimental for the durability.
- Influence of the adhesion of middle plates and sliding plates. When adhesion disappears, the stress concentration previously described increases.

- When exposed to temperatures around $23\text{ }^\circ\text{C}$ PTFE, the coefficient of linear expansion becomes drastically large, and consequently the difference in thermal expansion between the PTFE plate and the steel plates increase. This generates stress in the connection between the middle plates and the sliding plates decreasing the adhesion.
- The deformation of the upper shoe affects the sliding plates in some way.
