High damping rubber isolators: Application to bridges in Bangladesh

A. Arafat, J. Lopez Gimenez & T. Himeno

Engineering Division, Kawakin Core-Tech Co., Ltd., Kawaguchi, Japan

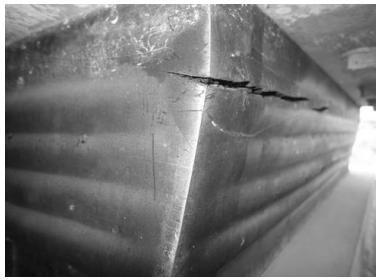
(a) Ozone cracks appearing on a poor quality rubber bearing

Figure 9. Ozone cracks and treatment of existing bearing using K-Coat-R

Ozone can destroy the double bonds of the carbon atoms of rubber and thus, make the rubber weaker. As a result, microscopic cracks appear on the surface. Accompanied with the ozone cracks, rubber bearings constantly undergo changes in shear deformation due to expansion and contraction caused by temperature changes of the girders. The continuous movement of the bridge can widen the ozone cracks, which directly affects the durability of the rubber bearing. Therefore, a coating material that has both weather resistance and the ability to follow the shear deformation of rubber bearings is required.

K-Coat-R has also proved to be effective with different rubber material types (Natural rubber (NR) and Chloroprene Rubber (CR)). Other experiments were carried out to verify the performance of K-Coat-R and when compared to silicon coat, the performance was significantly better. Figure 8 shows the specimen shape, testing machine and different experiments setting on rubber. Figure 9 shows a real example of using K-Coat-R for the treatment of an existing bearing. The treated bearing did not show cracks for 5 years after treatment.
