Post-disaster construction and bearing replacement of Bahaddarhat flyover

M. Azadur Rahman & Sohrabuddin Ahmad
Acumen Consulting House Ltd, Dhaka, Bangladesh

ABSTRACT: A 1.37 km long four-lane flyover has been commissioned in October 2013 at Bahaddarhat in Chittagong city. Structural system of the flyover consists of precast post-tensioned concrete I-girders acting compositely with cast-in-situ reinforced concrete deck slab. On two occasions during construction one or more girders accidentally fell to the ground below. The latter accident caused fourteen fatalities. Post-accident investigation revealed serious flaws not only in construction, but also in design, supervision and project administration. Following an assessment of condition of the completed works, a systematic approach was adopted to repair and renovate the faulty works and complete the remaining works. The faulty elastomeric bearings were replaced after commissioning of the flyover. Recommendation for simple modification to end diaphragm design to aid bearing replacement is put forward. It is demonstrated that careful attention to details and a scientific and systematic approach can ensure safe construction and an a

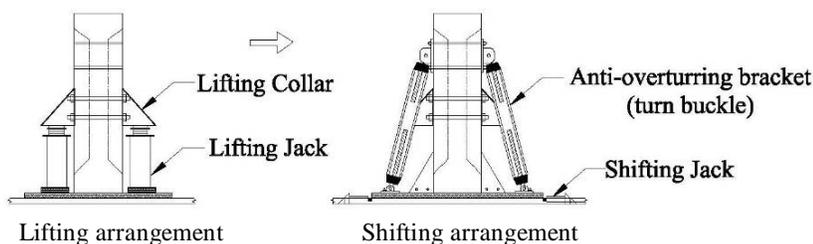
Construction methodology for the deck superstructure of this flyover involved casting, tensioning and grouting of girders on overhead casting beds. Subsequently they were lifted and shifted by jacks to their designated locations on bearing pads. Throughout the lifting and shifting procedure the girders would be laterally unsupported and thus highly unstable. Sometimes the girders were rested temporarily at some intermediate location adding to the number of such unsafe operations. Although highly risky, this is a common method of construction of such decks in this country, especially as adequate room for casting at ground level and then lifting and positioning by cranes is often not available. It is to be noted that it is this shifting operation that caused tipping of three girders that fell to ground in the second fatal accident. Safety concern during shifting of girders and also while resting individually at a location prior to stabilization by diaphragms demanded some modification of the procedure to improve safety.

Figure 8. Anti-overturning brackets for girder shifting

Preparing the girders in pairs or threes, tying them together with diaphragms and then shifting them together were considered, but the methodology would involve substantial additional time for completion. Instead a simple stabilization arrangement by brackets was devised and the girders shifted individually. The arrangement is shown in Figure 8. It consists of a pair of anti-overturning brackets fitted at each end of a girder attached to the travelling wooden sleeper used for shifting. The anti-overturning bracket was fabricated with a purpose made heavy duty long turnbuckle attached by pin ends to girder and wooden sleeper. The arrangement proved to be effective as any tendency of tilting of the girder during horizontal travel was prevented by the brackets.

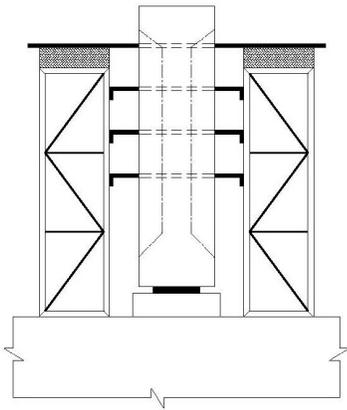
Figure 9. Stabilizing arrangement for girder standing alone

Besides during shifting, the girders are unstable even while standing at a location until several of them are tied together by diaphragms. To improve stability of individual girders while standing alone, a similar concept was utilized and a stabilizing arrangement implemented. The arrangement is shown in Figure 9. It consists of a pair of supporting posts attached by bolts to the girder at each end.
