Rehabilitation of Meghna and Meghna-Gumti bridge superstructures

ABSTRACT: The two bridges on Meghna and Meghna-Gumti rivers on Dhaka-Chittagong highway have been serving road traffic for the last 15-20 years. They had deteriorated significantly and their safety and serviceability threatened due to a virtually non-existent maintenance program. Mid-span hinge bearings of both the balanced cantilever box girder bridges had worn out and the reinforced rubber expansion joints had all but disappeared. The deck deflected and vibrated significantly as heavy vehicles passed, the piers swayed, riding over the expansion joints became bumpy and dangerous. A major rehabilitation work was recently undertaken which involved installation of new expansion joints and replacement of hinge bearings to stabilize the bridges. This paper describes the rehabilitation works, including inter alia design of new expansion joints, and material and method adopted for replacement of hinge bearings. It also addresses implementation issues and experience including bridge closures for minimum interruption.

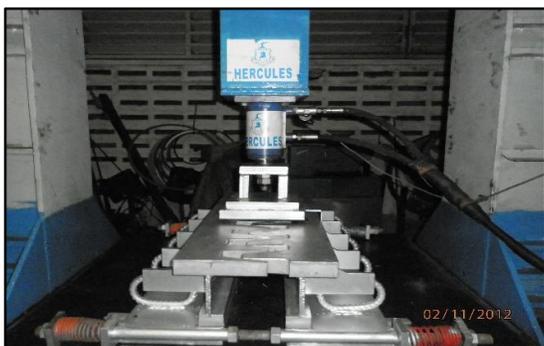
Figure 7. Fatigue testing of expansion joint.

The finger joint was fatigue tested after manufacture to evaluate performance under repetitive loading conditions (Fig. 7). Figure 8 shows an assembled finger joint prior to installation.

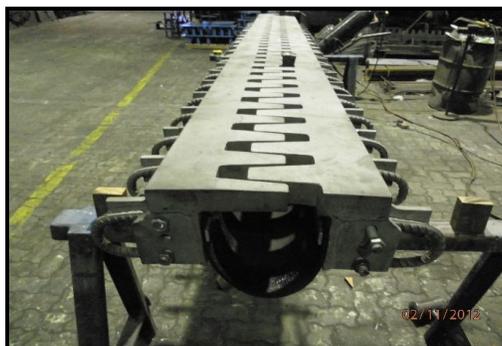
Figure 8. Fabricated expansion joint assembly.

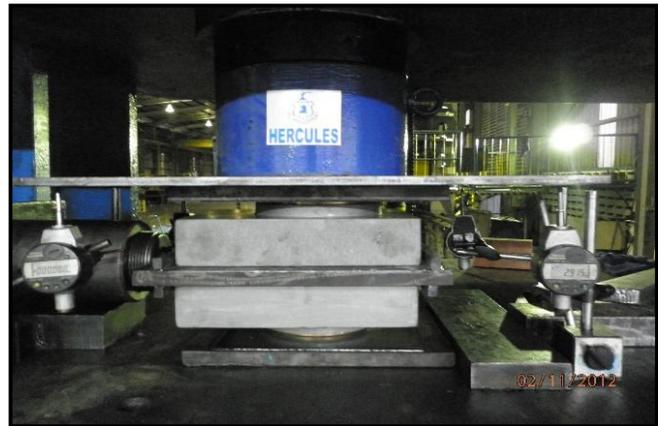
Figure 10. Long term deterioration test on hinge bearing.

The permanent bearing was a modified version of the original design to BS 5400 with dimpled brass sliding disc (Fig. 9). The new design has a thicker sliding plate, the stainless steel material having been changed from S304 to the more durable S316. Although long term deterioration tests were conducted on the assembled hinge bearing (Fig. 10), when tried in field, this modified version of original design was not very successful because the dimpled brass disc could not withstand the prevailing frequency of combined movements. Despite having greased the brass discs frequently, they were worn out within a short period after installation. It was felt that a non-metallic material would form a more abrasion-resistant sliding surface. After considerable test and trial, ultra high molecular weight polyethylene (UHMWPE) was chosen as material to be used on piston tops of pot bearings to act as the sliding surface. Originally installed dimpled brass discs were replaced with custom-designed and machined dimpled discs using UHMWPE material. This special design UHMWPE disc has proven to be successful ever since under extreme service movements and rotations (Fig. 11).

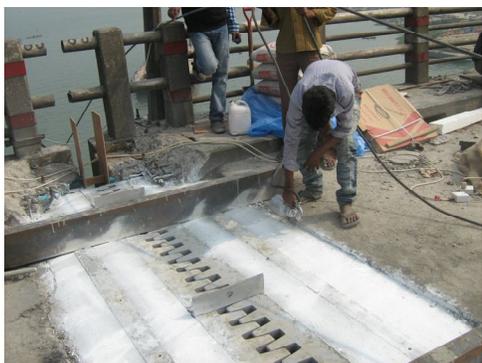
Figure 15. Application of curing compound after casting.

The casting of concrete box-out using specially designed concrete, mixed at site, proved to be effective. A high early strength, high range water reducing/superplasticising admixture was used as the key ingredient of concrete. Concrete strength reached more than $f_c' = 30\text{MPa}$ at 48hrs and $f_c' = 50\text{MPa}$ at 28days. A curing agent was sprayed on concrete surface after casting to reduce risk of shrinkage cracks due to high early strength. This proved to be satisfactory as there was only a 50mm minor hairline tension crack out of all the expansion joint locations, this again presumably caused by uncalled for movement of construction equipment on the deck when the concrete was still green. Figure 15 shows a concrete casting being finished and Figure 16 shows a finger joint after installation.

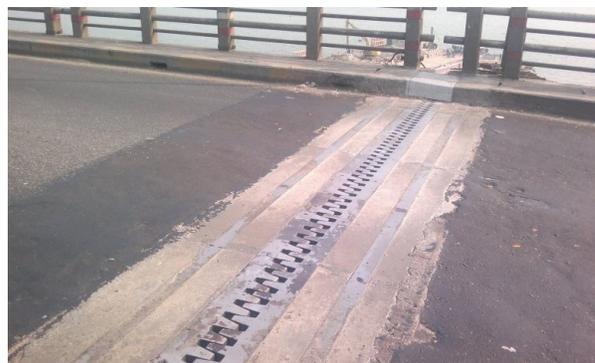
Figure 16. Installed finger joint.

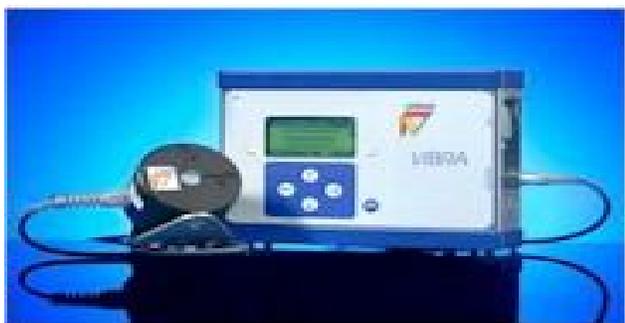
Figure 17. Vibration monitoring equipment.

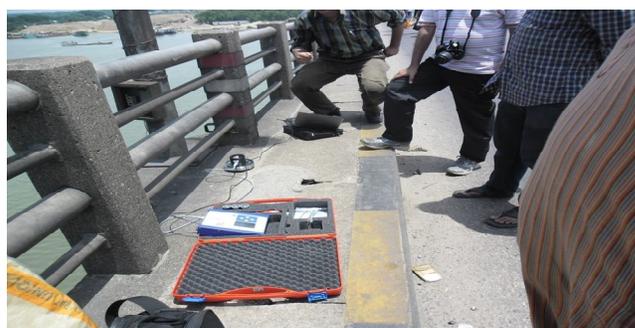
Vibration of the bridge was measured before and after the rehabilitation by electronic vibration sensors and loggers that can record vibration in all three dimensions. Figure 17 shows the equipment employed for this measurement and Figure 18 shows vibration monitoring work on bridge deck. Figure 19 and Figure 20 respectively show typical vibration records before and after the temporary rehabilitation works. Peak velocity of 80 mm/s prior to rehabilitation had reduced to below 60 mm/s after the temporary works. The measurements were however taken over a short period of time (30 minutes) and may not represent typical traffic condition on the bridge.

Figure 18. Vibration monitoring in progress.

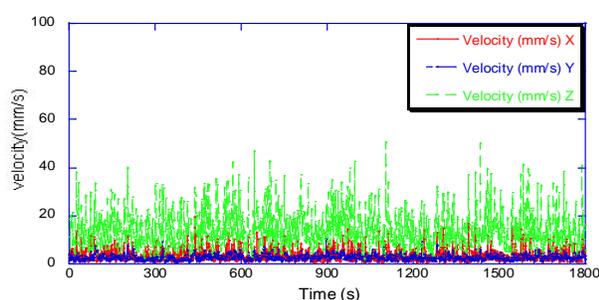
Figure 20. Vibration after temporary rehabilitation works.

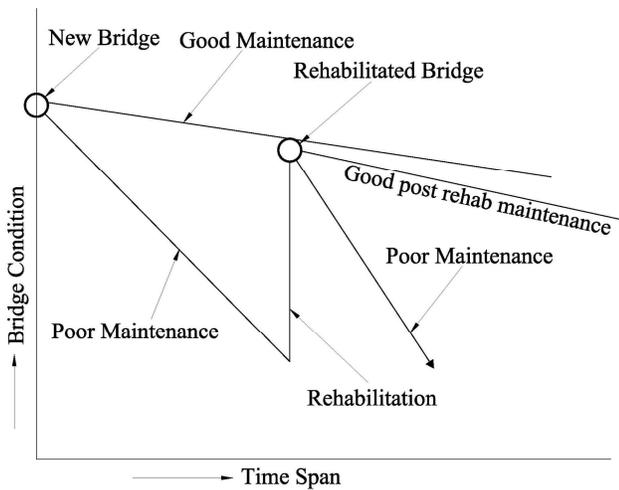
The extensive rehabilitation works were necessitated by slack in regular maintenance. All infrastructure works especially bridges need maintenance. Figure 22 is a conceptual representation of deterioration of bridge condition with age, which can be slowed down by good maintenance. Rehabilitation works cannot make the bridge new; it can at best lift the bridge condition to a level which could have been achieved at this age by good maintenance. The rehabilitated bridge will deteriorate at a greater rate than the original bridge even with good maintenance. Without such continued maintenance even the rehabilitated bridges will soon deteriorate rapidly and return to a condition worse than before.

Figure 22. Conceptual representation of bridge maintenance need.
