# Structural condition assessment of bridges and culverts in national highway N7

**ABSTRACT:** Deterioration of structures with the passes of time especially for bridges and culverts is a common phenomenon all over the world. Deterioration may happen due to different reasons like poor construction quality, overloading, and structural inadequacy, lack of maintenance and monitoring, ground settlement and weathering effect. Due to lack of timely mitigation measures, deterioration often causes the severe structural damage and warrant untimely expensive repair or replacement of the structures. In Bangladesh, the growth of economy is consistent for the last few years and accordingly blooming in transportation sector happened. To meet the future traffic and transport demand some of the road structures mainly bridges and culverts are being structurally inadequate. Recently a survey has conducted to assess the structural conditions of bridges and culverts on National Highway N7. On the basis of which, an up-to-date inventory was prepared. The survey results signify that some of the bridges and culverts are inadequate to carry the increased traffic load. Some of them are at slightly deterio

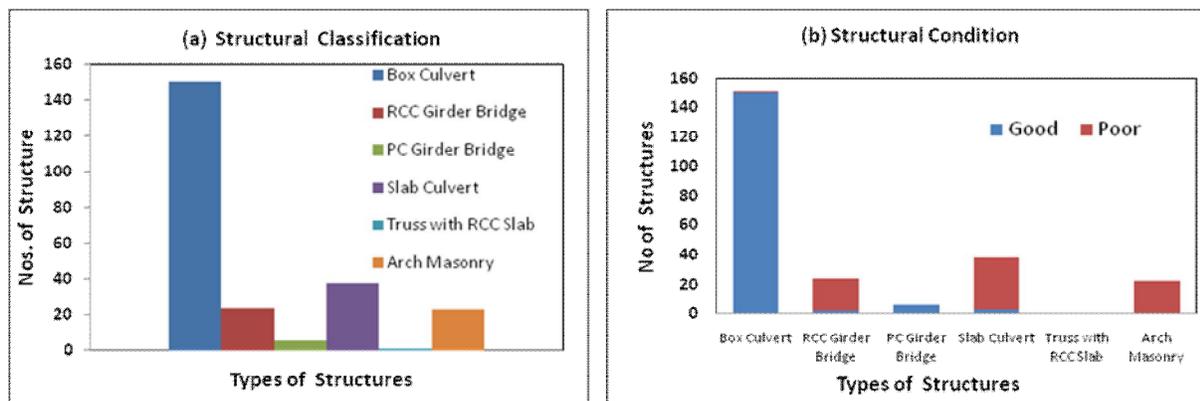
Figure 3. Structural classification in (a) and structural condition in (b)

It was observed that a good number of structures deteriorated over the years after construction due to different factors. It was clearly observed that Box Culvert, PC Girder Bridge, Arch Masonry and Truss structures performed well than RCC Bridge and Slab Culvert. The actual deteriorated condition of these structures is presented in Figure-4. The deterioration may be occurred due to different conditions like repeated overloading, unexpected extra loading before the life expiry period, quality control during construction, inappropriate maintenance and lack of regular inspection as well as monitoring, weather conditions, improper drainage and gradient and reinforcement corrosion etc.
